Niantic Bay Overlook Project

**Entry-way Project Monument and Storm Damage of 11/9&10, 12/16/2005 and 1/18/2006
and Initial Pathway Destabilization Caused by Rain Storms of 2005**

Final Report

April 24, 2006

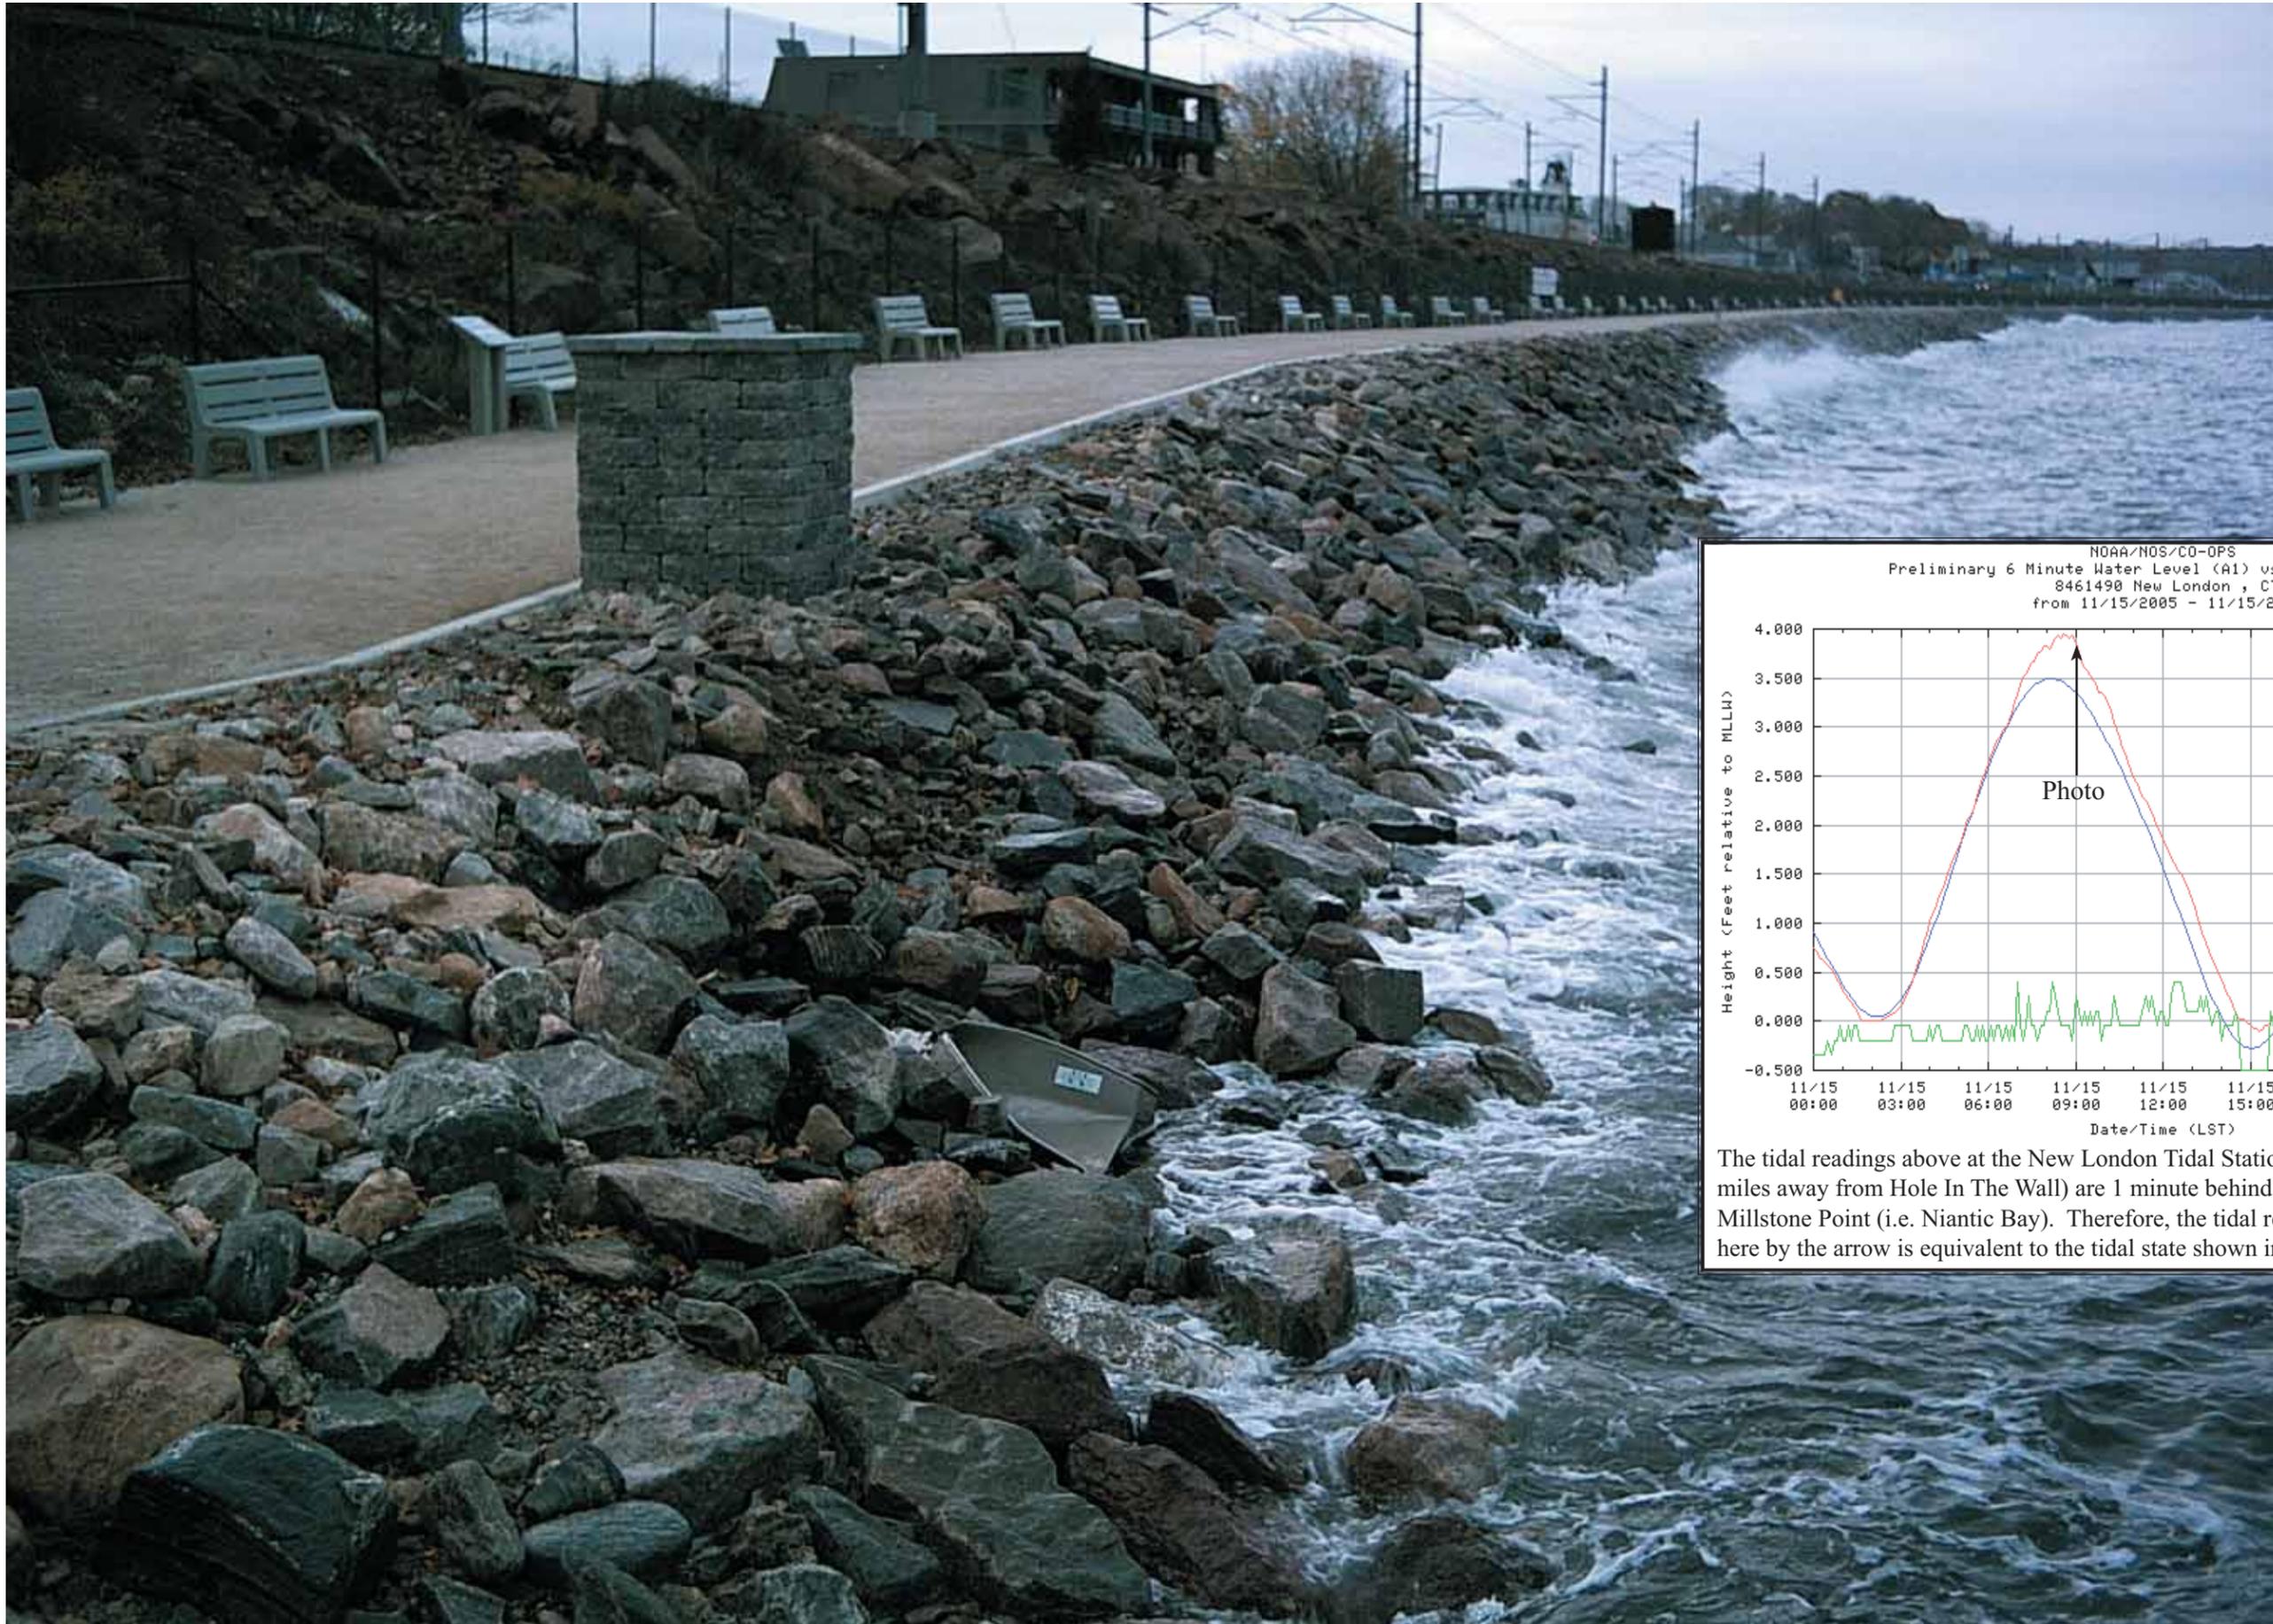
The two views of the study area at the left and right were taken at 0900 hours on November 15, 2005, during High Tide as determined by the unverified tidal gauge readings at New London, CT (#8461490). Weather was solid overcast with variable light south south-west winds, Barometric Pressure was 30.94 inches.

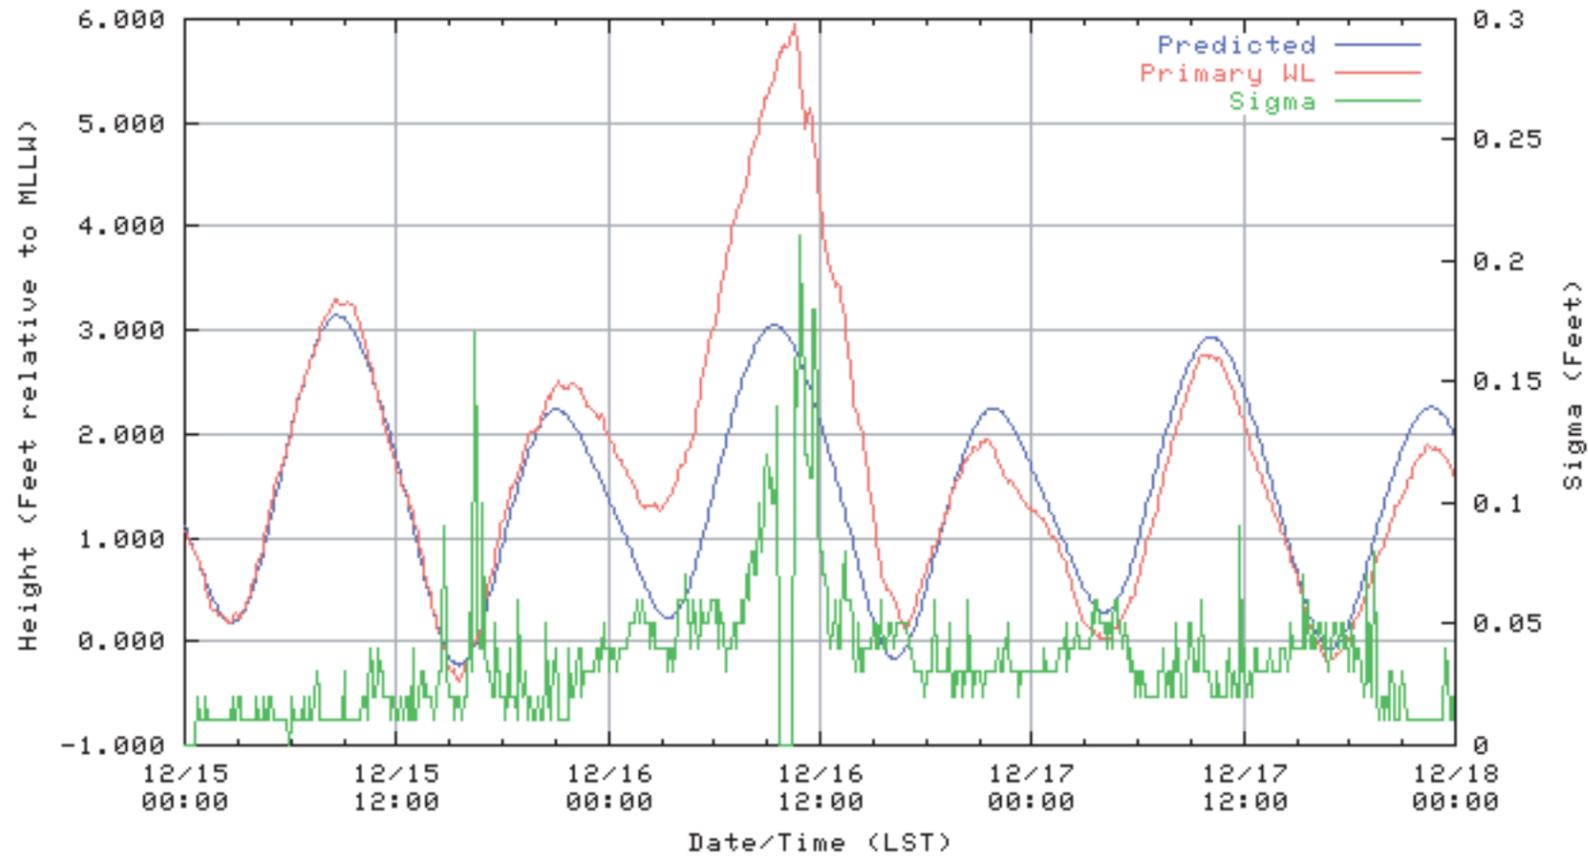
Tidal Cycle Recorded at the New London State Pier
Occurring 52 Minutes Before Niantic Bay *

NOAA/NOS/CO-OPS
Preliminary 6 Minute Water Level (A1) vs Predictions Plot
8461490 New London, CT
from 12/15/2005 - 12/17/2005

* The nearest National Oceanic and Atmospheric Administration (NOAA) Tide Station is located 9.7 water miles away from Niantic Bay Overlook. As a result, the tidal cycle recorded at New London precedes the same tidal cycle at Millstone Point (i.e. Niantic Bay) by 1 minutes. It is virtually of the same magnitude. The plot above is taken from: NOAA/NOS/CO-OPS Water Level Station Data (http://140.90.121.76/cgi-bin/co-ops_qry_direct.cgi?stn=84611490+New+London+%2C+CT&dcp=1&ssid=A1+-+Acoutoc+WL...)

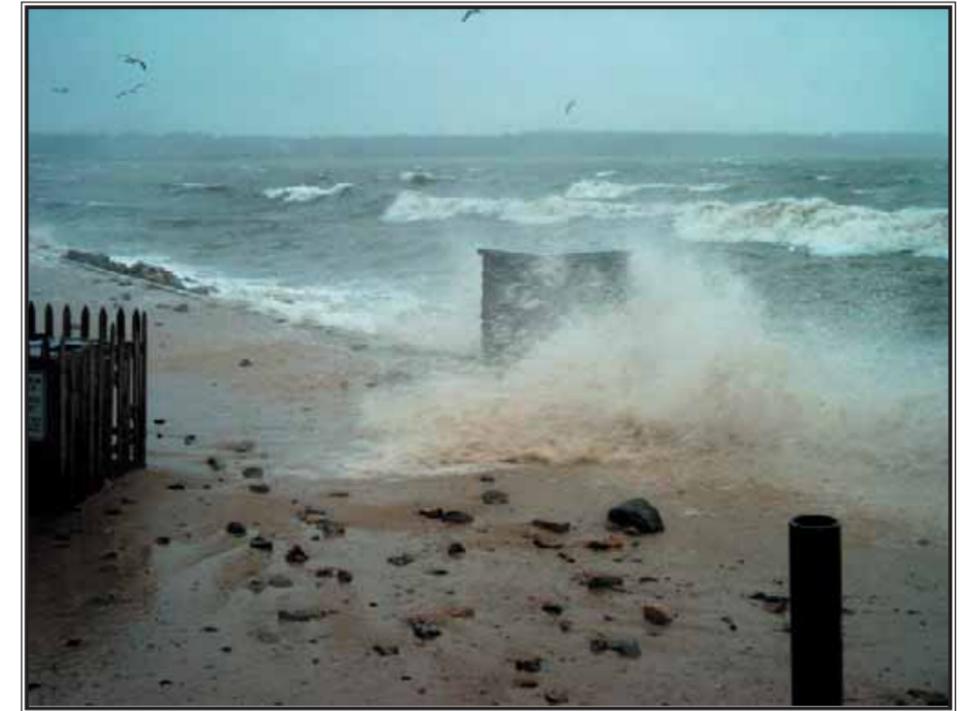
During the morning of December 16th, winds from the South-East with sustained gusts of 40 mph, drove waves at the Overlook during an extreme high tide that was twice the height of the normal extreme high water for that date. Here, they are seen breaking over the Monument at 10:00 am ±.

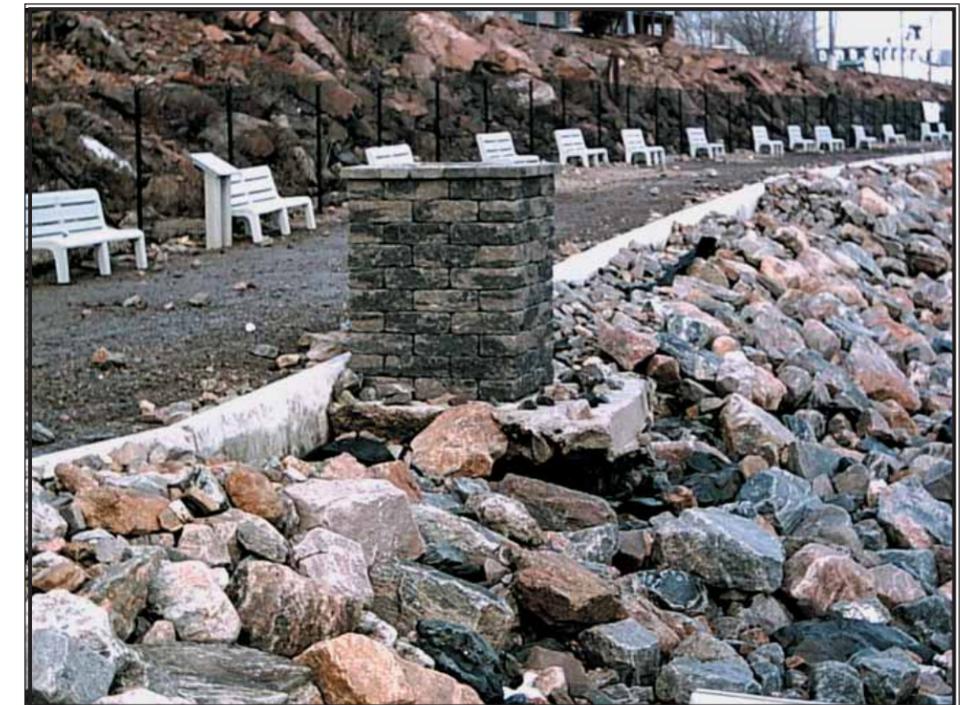
Although the ELPTF Monument was not damaged, its surrounding rip rap was eroded leaving its foundation exposed as is shown here photographed at 2:30 pm, December 16, 2005. Note the stones cast onto the path.

walkway and drainage easement, places its seaward face in the wave field during onshore storms. Its foundation can be protected against erosion by rip rap to armor it against damage, but the present stone, if not augmented, will not provide that long term protection.

The monument is placed immediately East of a drainage easement that contains the storm drain pipe from the Hole In The Wall Parking Lot on the north side of the railroad embankment. The foundation of the monument consists of stone dust on construction fabric protected from erosion by a subsurface concrete form. That is covered by about one foot of small rip rap.

Conversation with the Town Engineer, Keith Heyden, resulted in agreement that stabilizing the monument by use of placed rip rap would be acceptable. Present plans are temporarily suspended until such time as a completed damage report is completed by East Lyme.

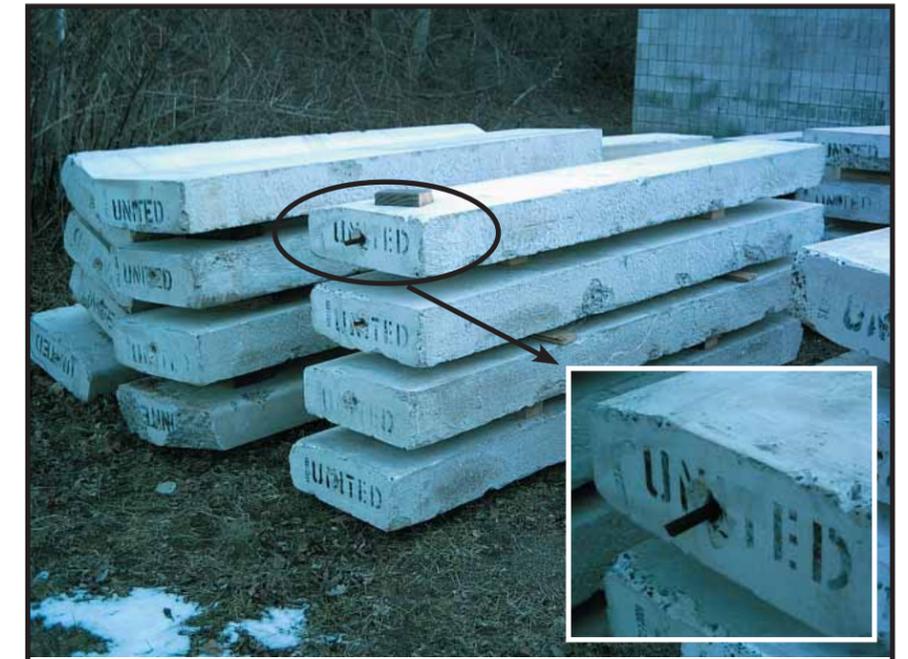
Prefabricated, concrete curbing (8 ft x 20 in. x 7 in.), were used to form the seaward edge of the western 2,743 foot long Overlook walk way. Forty-eight of these sections were removed from eroded por-

tions of that walk way following the coastal storms of December 16th and January 18th. Shown here in temporary storage in the parking lot adjacent to the Hole In The Wall underpass, the inset is a detailed view of the Re-Bar pin used to align curb units with one another when they are set end to end along the seaward edge of the walk way. Photographs A, B, and C on the following pages show the consequences of the erosion of fines, coupled with storm wave shifting of rip rap that caused collapse of the curbing. The locations along the Overlook from which these curb sections were removed are illustrated in the aerial photograph on page 9.

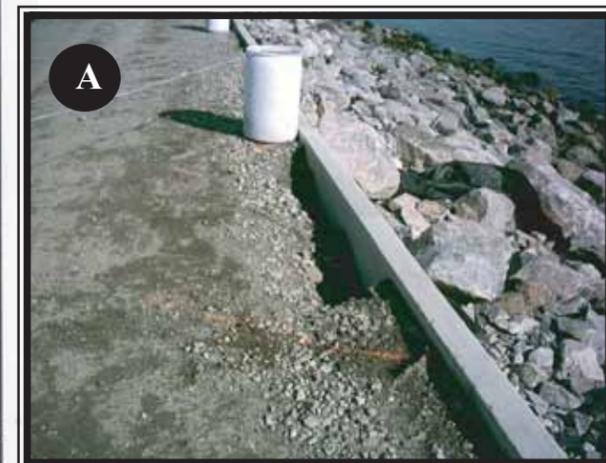
Subaerial erosion* of the Overlook path is seen in photograph 1 (2/16/06) as it appears between 2,088 and 2,100 feet east of Hole In The Wall underpass. The undercutting of the curbing, resulting from surface water eroding fines in the unconsolidated fill material, is clearly shown here to sink under the curbing and flow into the revetment face and then into the Bay, leaving the Overlook unstable and vulnerable to coastal storms which move the undersized rip rap and further erode the structure of the Overlook walk way.

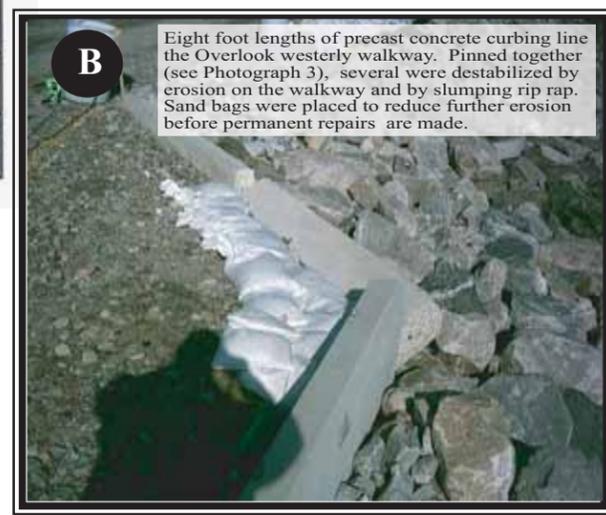
Subaerial erosion of the Overlook path is seen here between 826 and 842 feet east of Hole In The Wall underpass as it appeared on February 16, 2006. The destabilization caused by leaching of heavy rainfall leading from the adjacent railroad embankment and the Overlook walking surface, undermined the Overlook fill by removing fines from both the foundation of the walk way as well as from the revetment slope. Erosion of the walking surface was not pronounced and the most prominent signs of cumulative problems, unrecognized in their significance at first, was the regular appearance of muddy waters at the toe-of-slope of the revetment along the westerly 2,743 feet of the dirt Overlook between Hole In The Wall underpass and the elevated boardwalk.

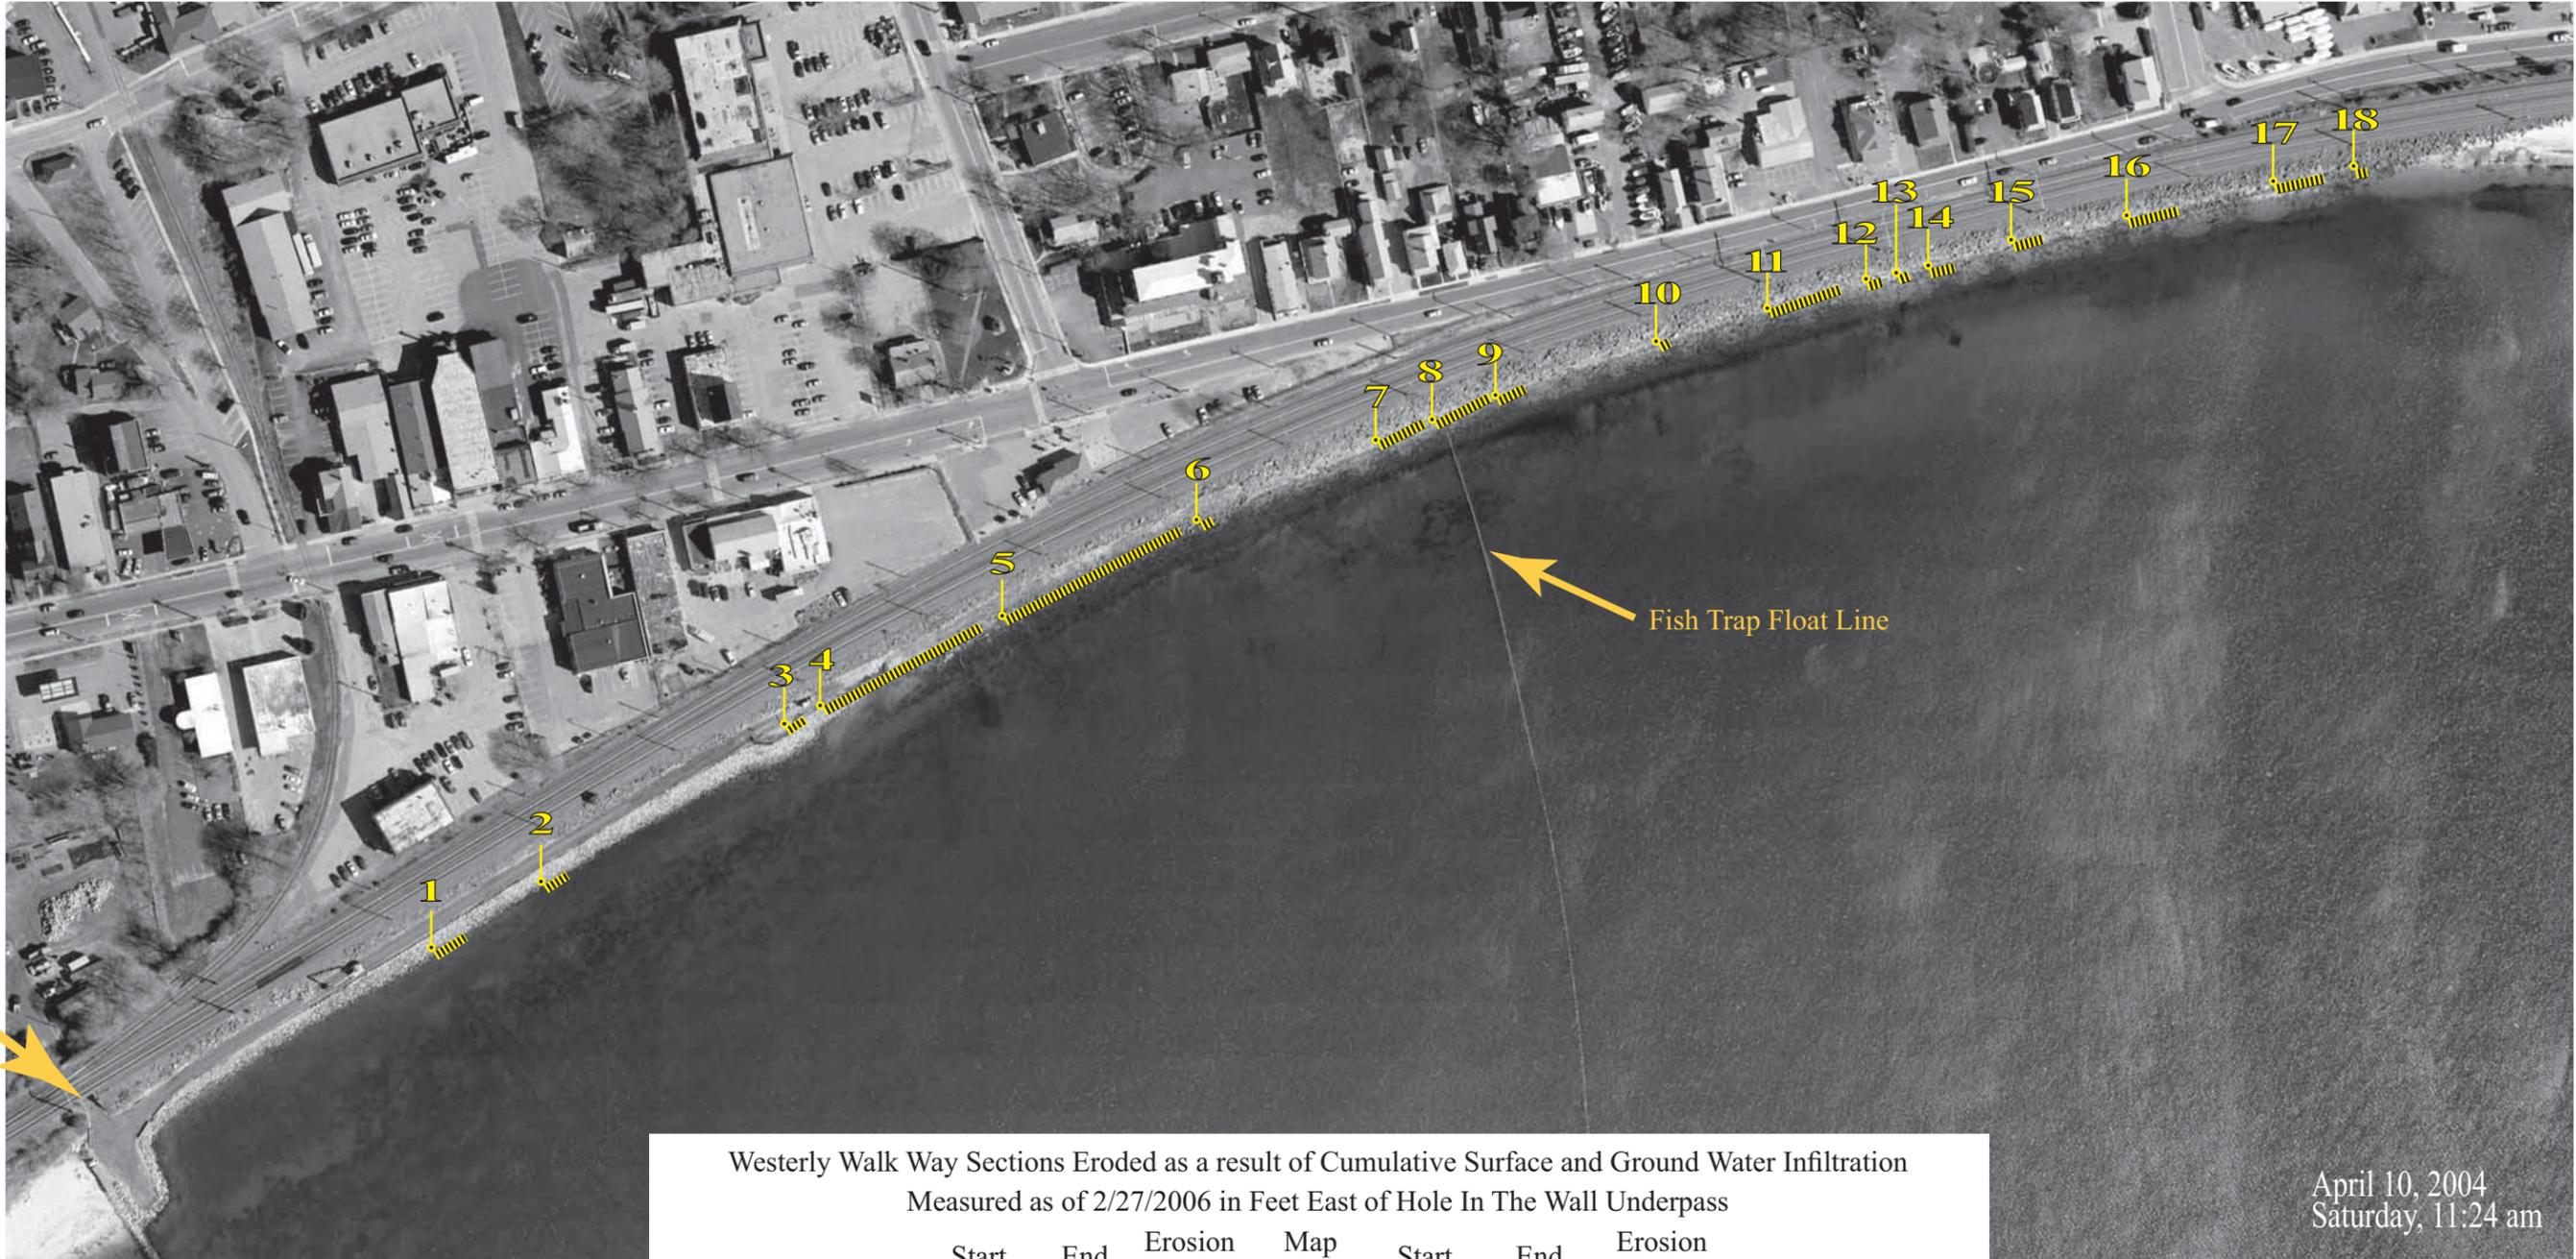
Westerly Walk Way Sections Eroded as a result of Cumulative Surface and Ground Water Infiltration
Measured as of 2/27/2006 in Feet East of Hole In The Wall Underpass

Total Length of Overlook Curbing Damage = $665 = \frac{665}{2739} = 24\%$

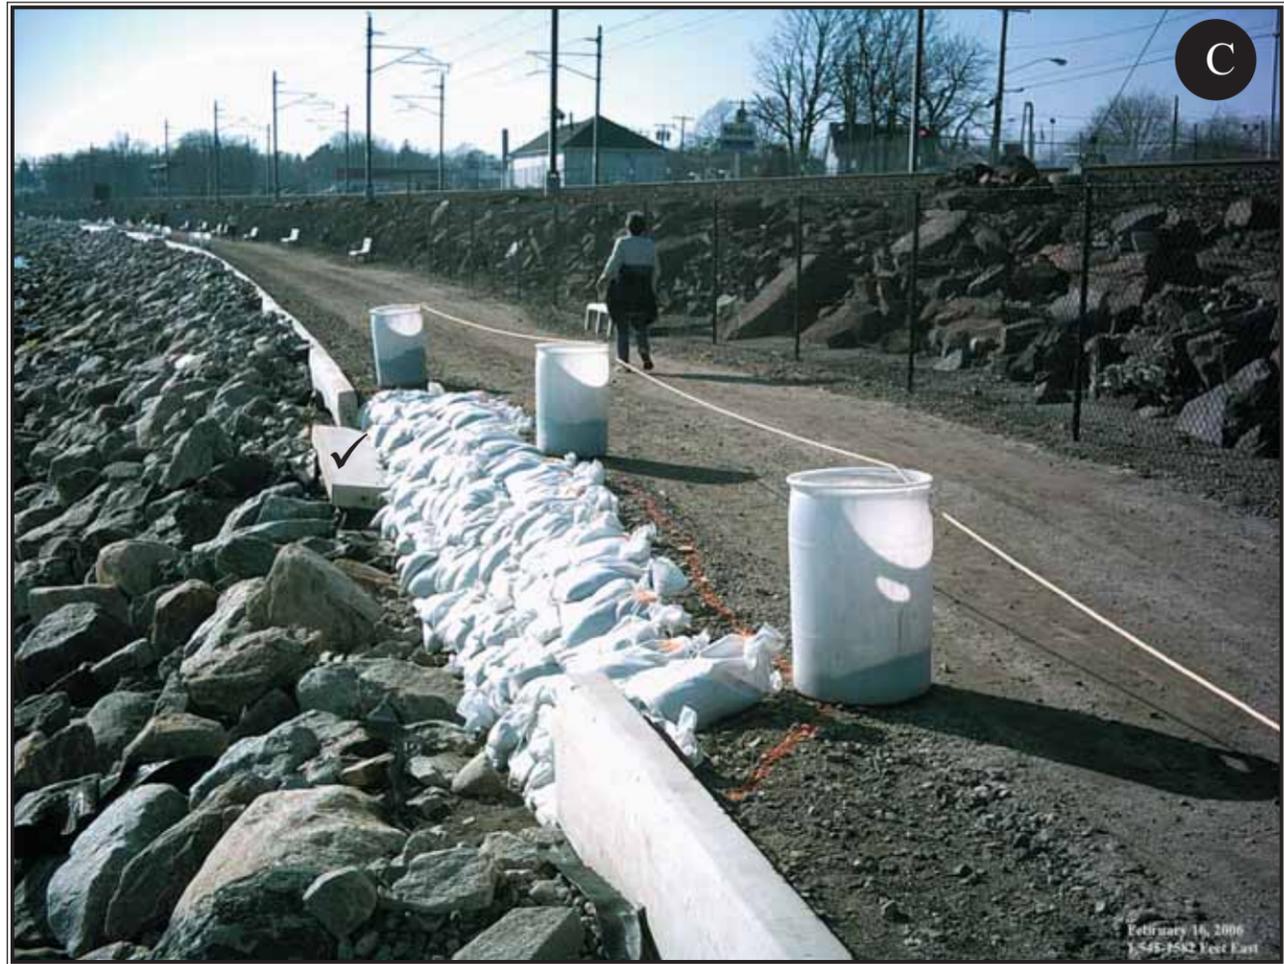
Subaerial erosion due to rain, coupled with coastal erosion due to waves, resulted in undercutting curbing, as seen in Figure 3, which is based on observations made on February 16, 2006, 1,549 feet east of Hole In The Wall underpass. Note how the 8 foot section of curbing (marked with a ✓) has fallen onto the revetment rip rap. Sand bags were placed after the December 16th storm as an emergency repair to protect the walkway from further erosion.

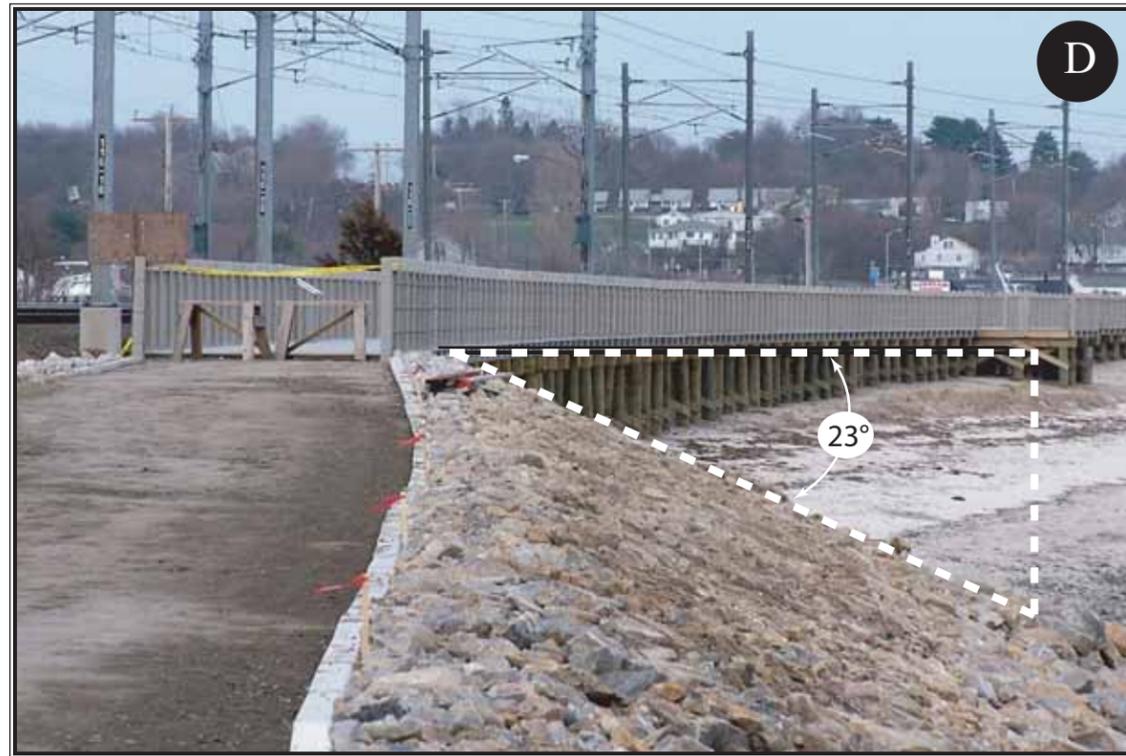
Looking easterly in Figure D toward the beginning of the elevated Boardwalk, this photograph was taken on April 8, 2005. Note the relatively even surface texture of the revetment in the foreground. This appearance results from the use of graded stone of relatively small size. That sloped fill material seen here still contains brown soil sediments.

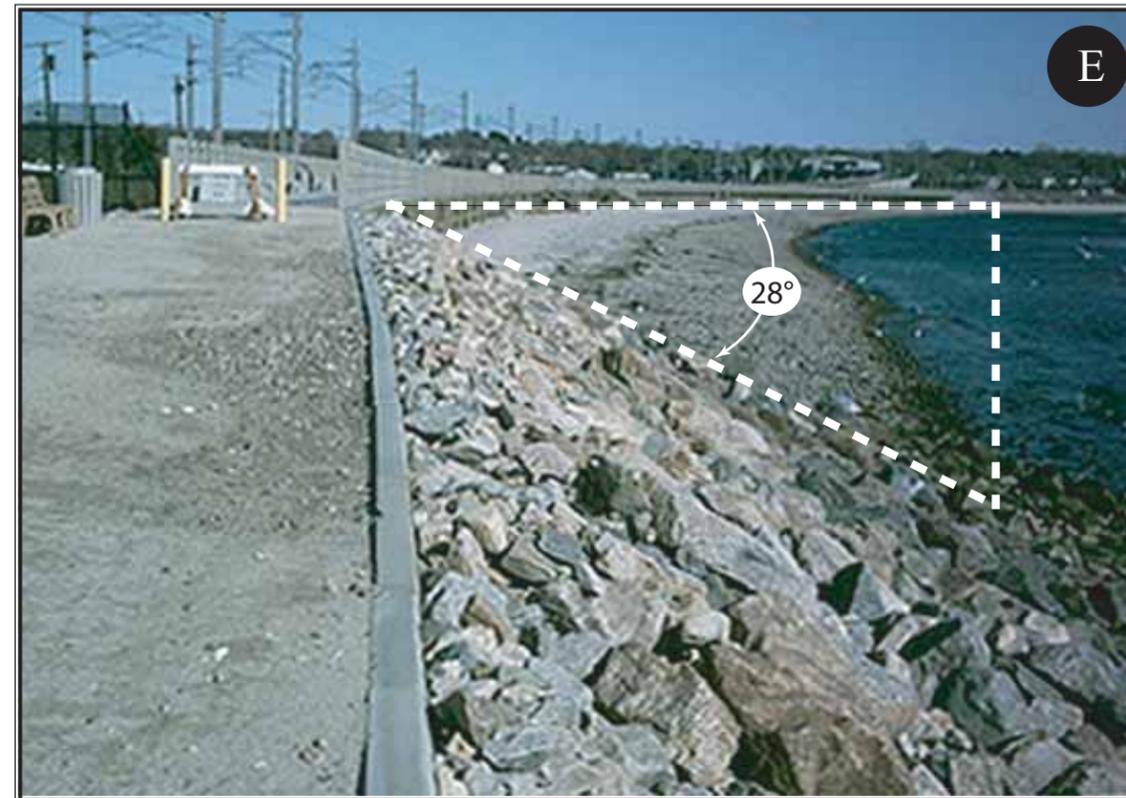
The photograph to the right was taken on February 27, 2006, approximately eleven months after the Figure D photograph to the left. Note the absence of brown soil and the absence of small stones that results in the rougher appearance of the slope. The slope at this location along the Overlook has increased by 5°. The soil and smaller stones have been eroded out of the revetment, causing the slope to increase and making the walking surface of the Overlook less stable and more prone to future washouts due to storm waves and/or rain infiltration. Such infiltration may cause further removal of fines from the walking surface foundation material, undercutting the curbing that would result in further collapse of the revetment and curb-

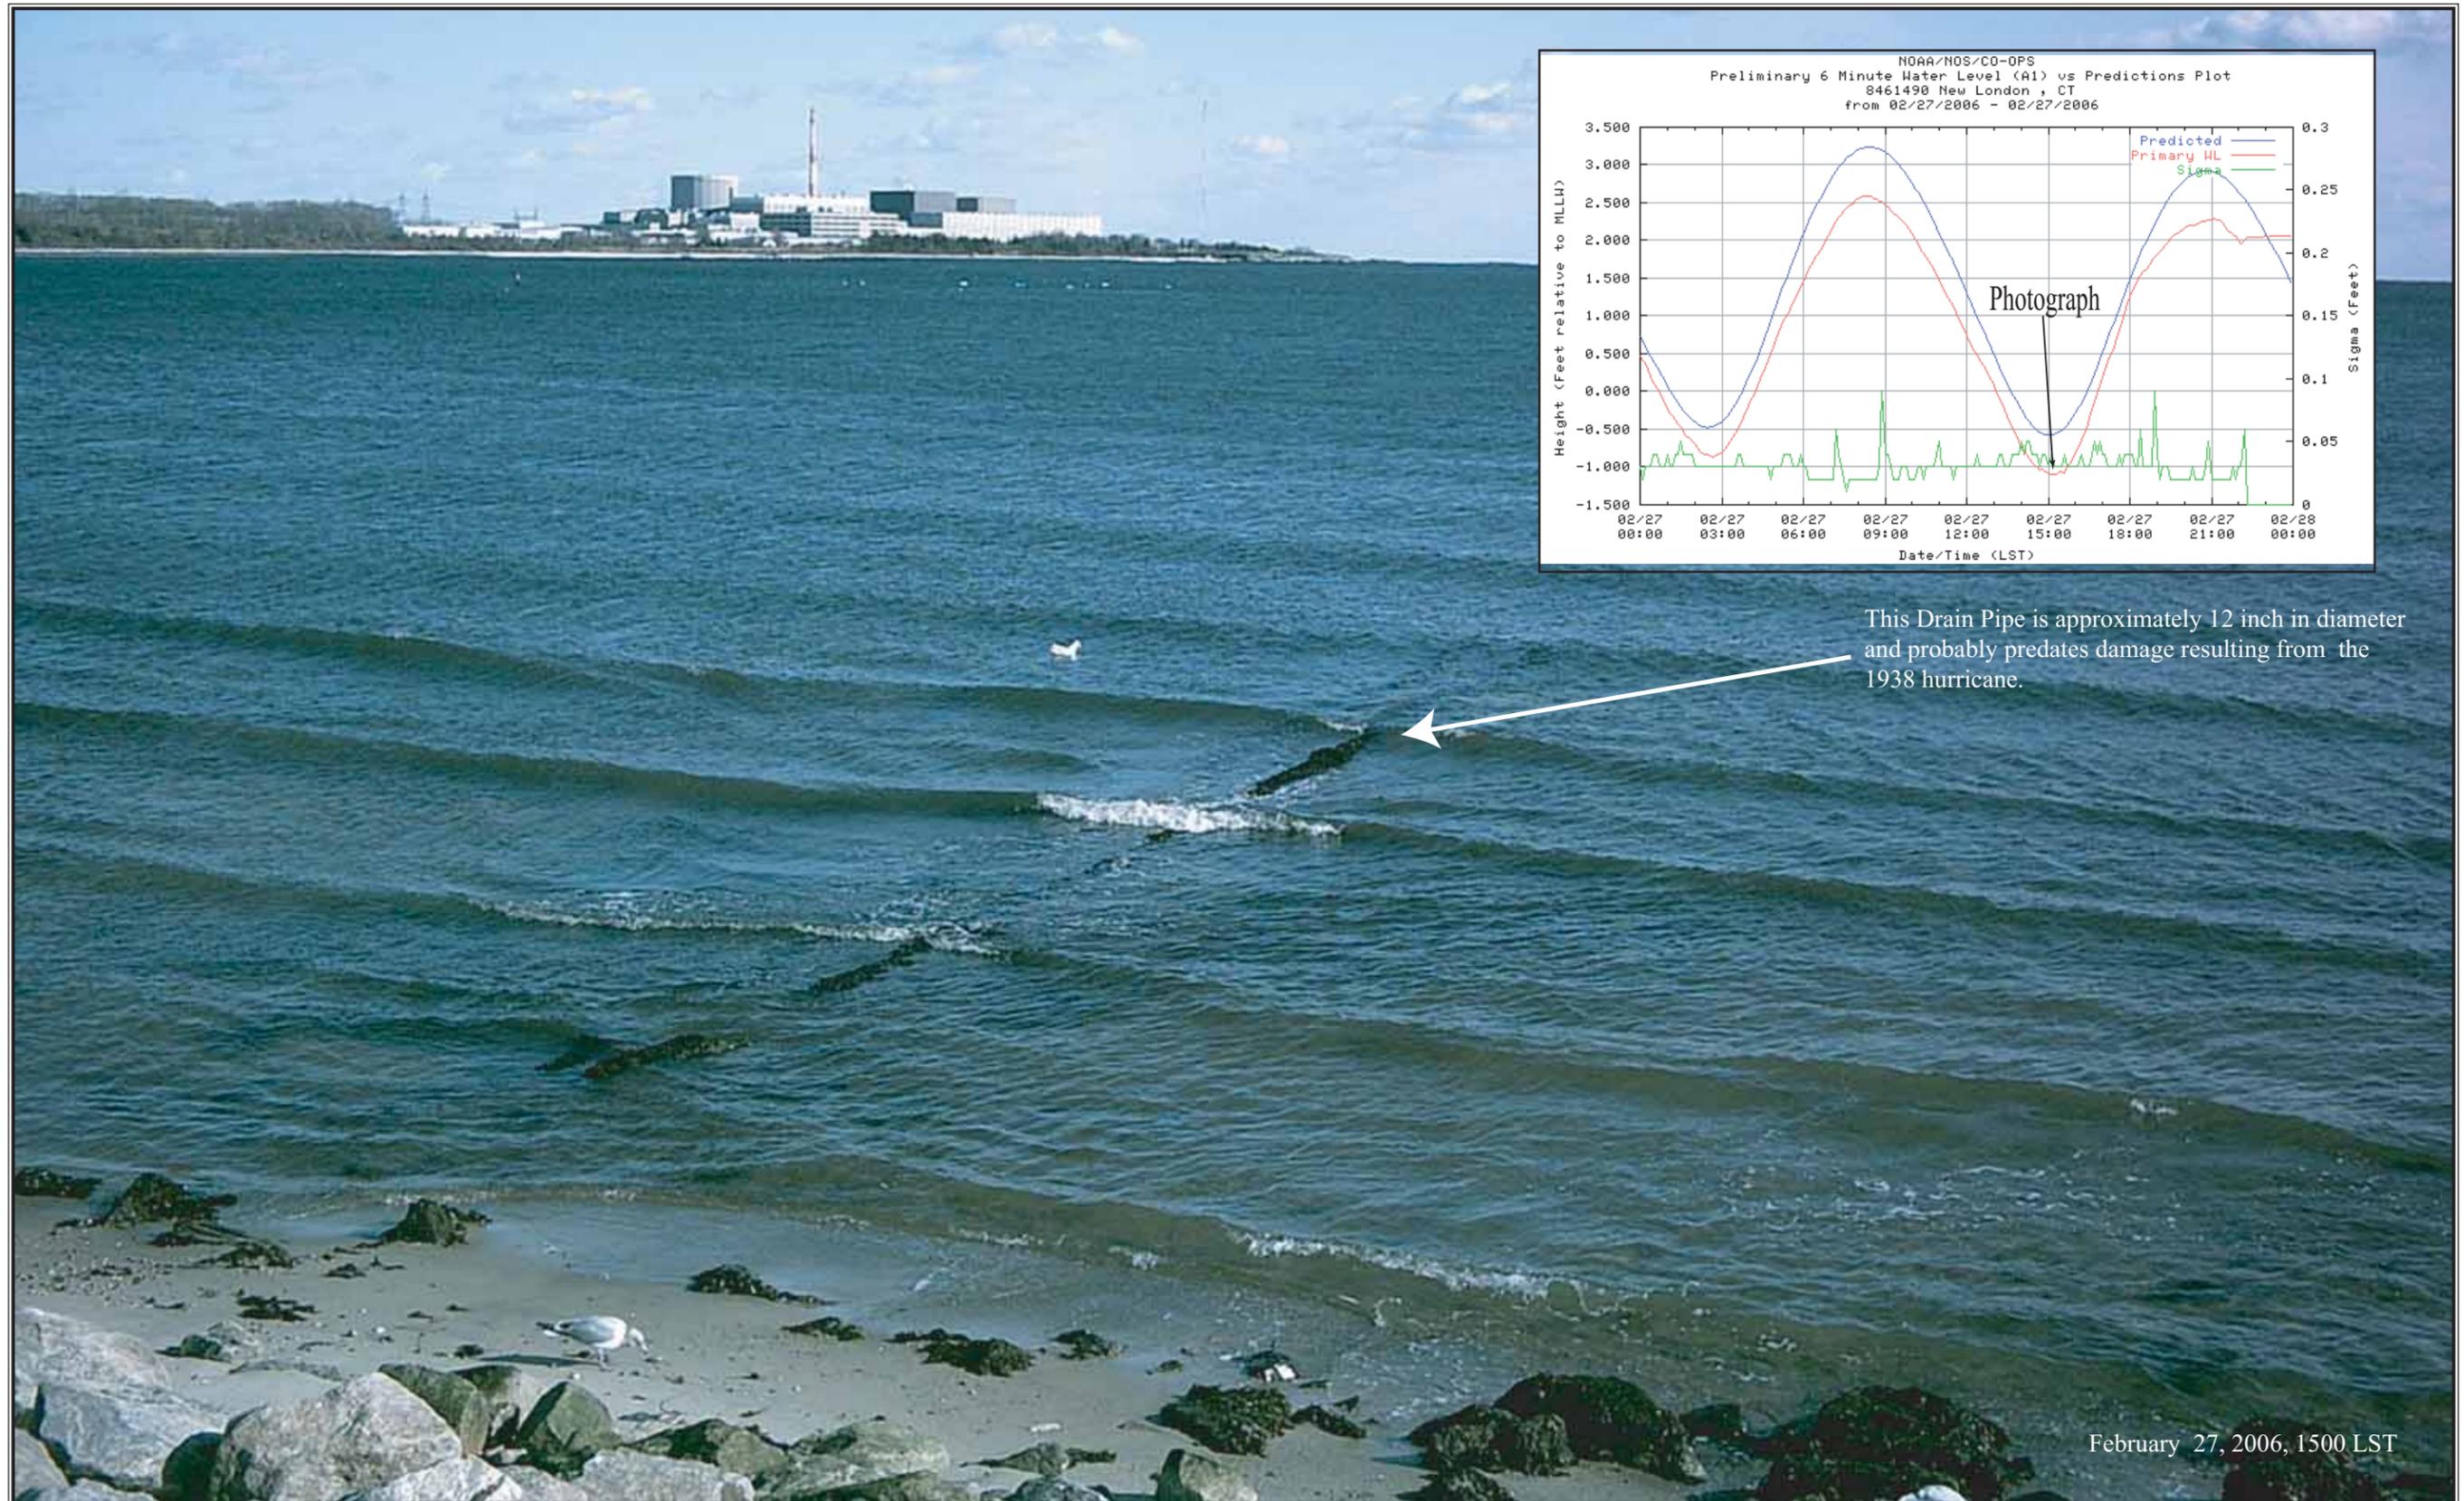
February 27, 2006, 1500 LST

This Drain Pipe is approximately 12 inch in diameter and probably predates damage resulting from the 1938 hurricane.

This photograph of Niantic Bay was taken from the Niantic Bay Overlook at a point on its westerly walkway approximately opposite the Morton House. The tidal plot inset above is from the New London NOAA station, which records the tidal range. This tidal cycle reaches Millstone Point (i.e. Niantic Bay) one minute later, according to NOAA predictions. On February 27, 2006, at 3:02 pm, the low tide in Niantic Bay was extremely low due to atmospheric conditions. The tide seen here was 0.55 feet lower than was predicted by NOAA. Observations made possible because of this extremely low tide, indicate that a sandy bottom exists along the length of the abandoned drain pipe.

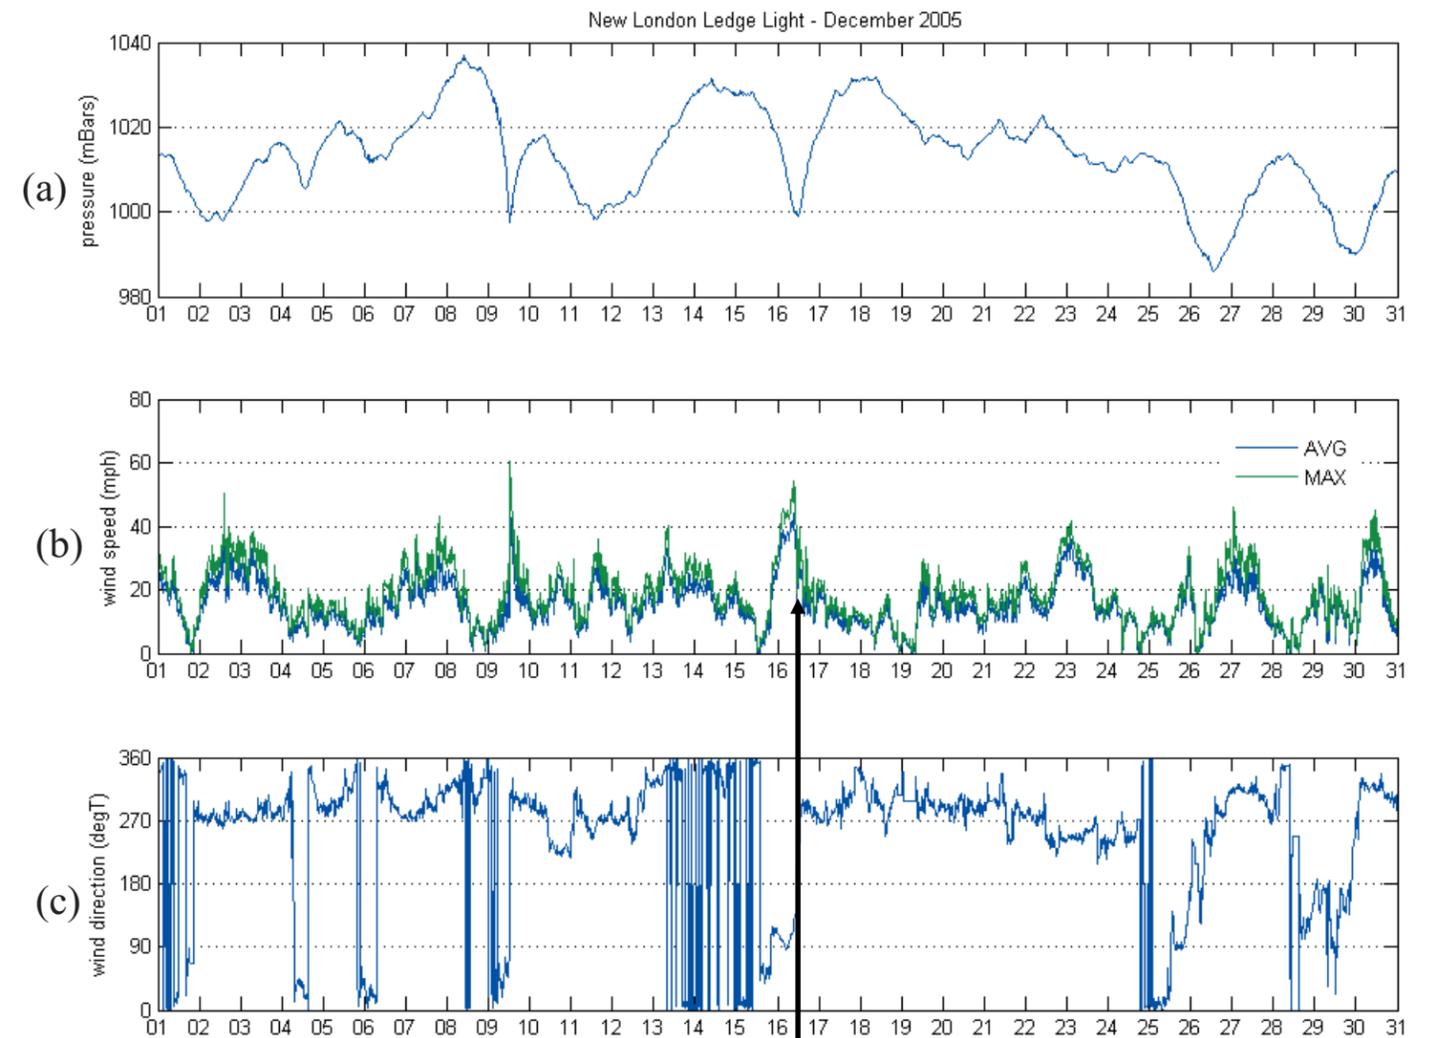
Figure 1 Meteorological Data – New London Ledge Station - December, 2005
(a) Barometric Pressure (b) Wind Speed (c) Wind Direction
Arrow Designates the Event of December 16, 2005

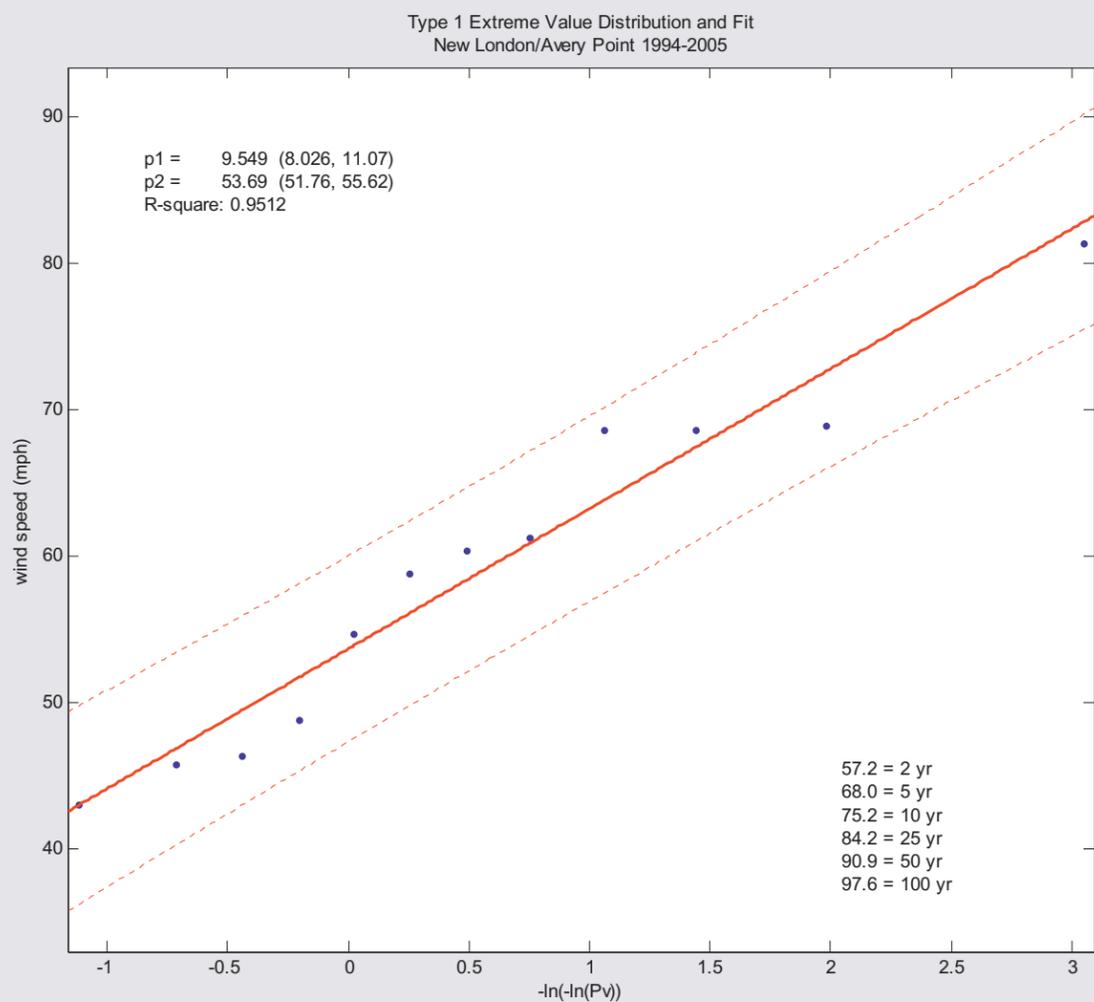
Figure 2 - Expected Recurrence Periods – Wind Speed
New London Ledge and Avery Point Stations
