Niantic Bay Overlook Project

**Entry-way Project Monument and Storm Damage of 11/9&10, 12/16/2005 and 1/18/2006
and Initial Pathway Destabilization Caused by Rain Storms of 2005**

Final Report

April 24, 2006

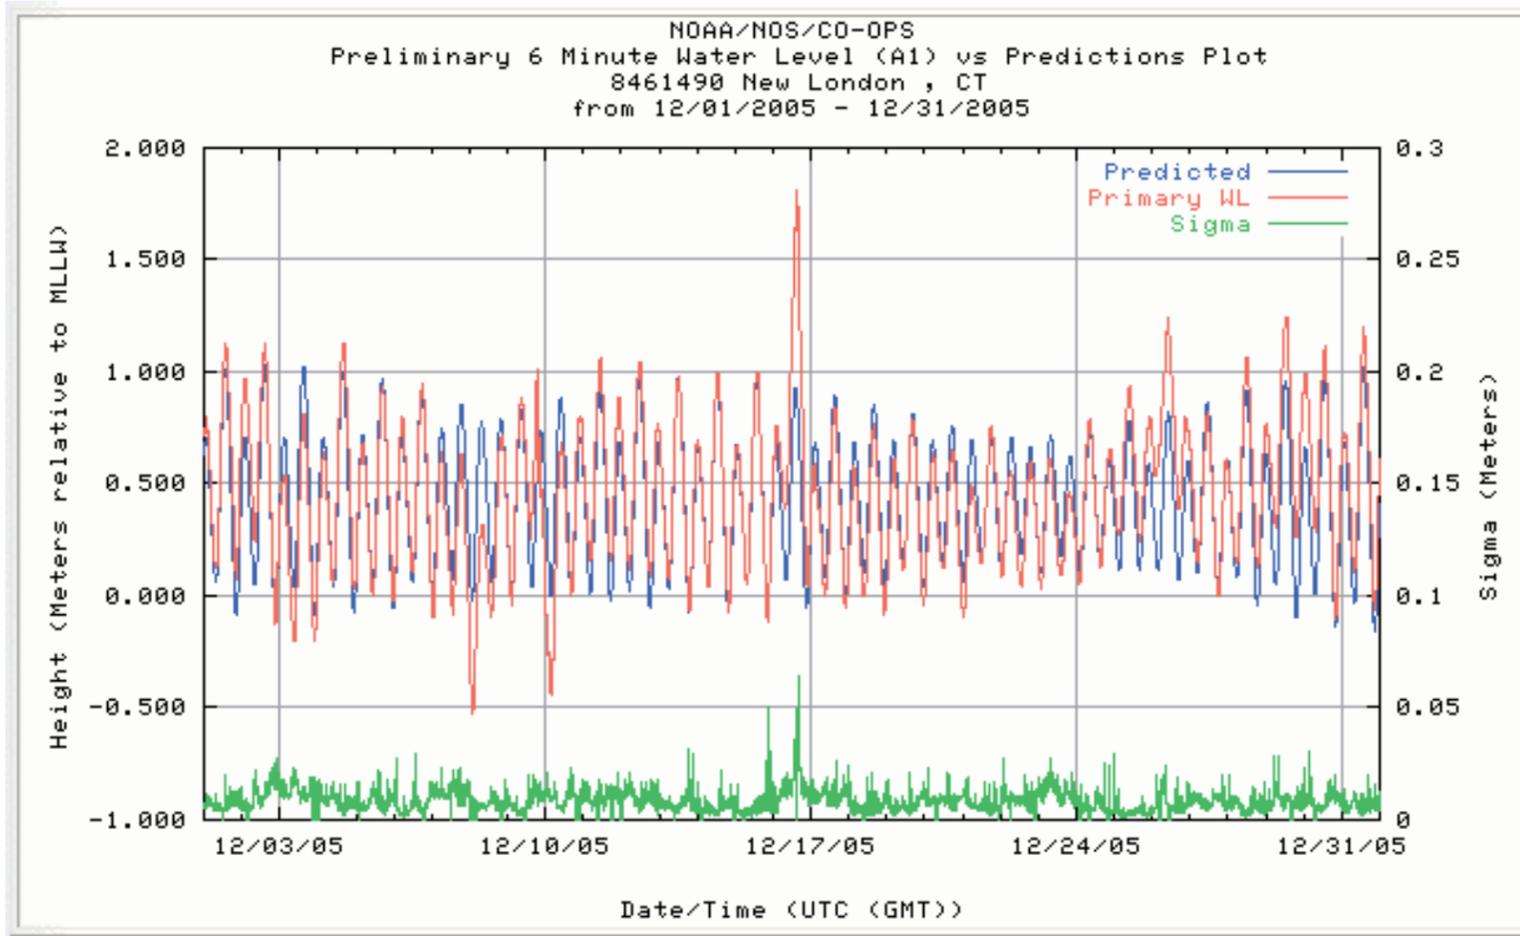
Figure 4 Tidal Elevations Predicted and Observed – New London Station – December, 2005

Note: Height in meters Time GMT

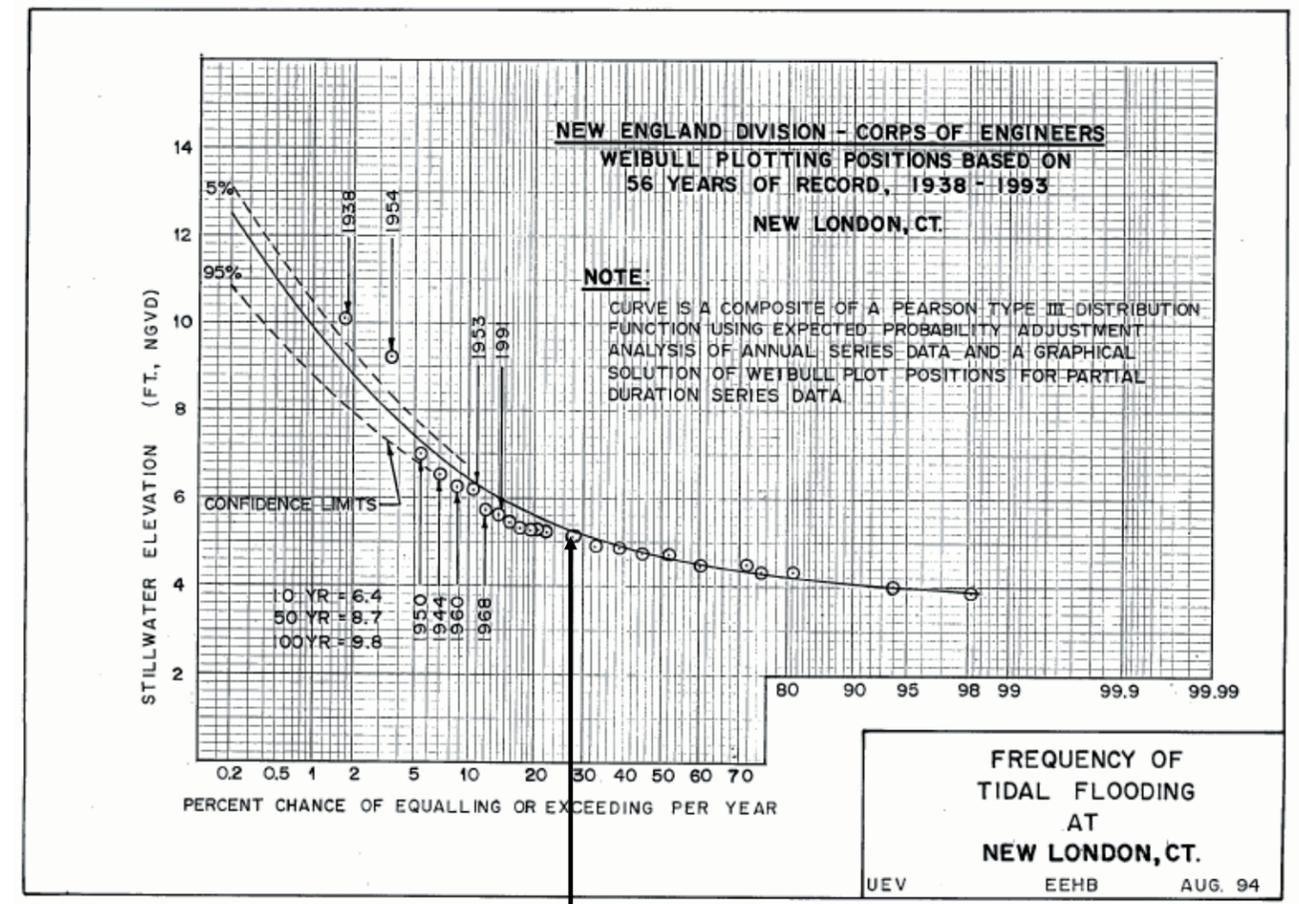
Figure 5 - Expected Recurrence Frequency – Tidal Heights – New London, Ct.

U.S. Army Corps of Engineers – Concord, Ma - File Data

Arrow indicates conditions associated with the event of December 16, 2005

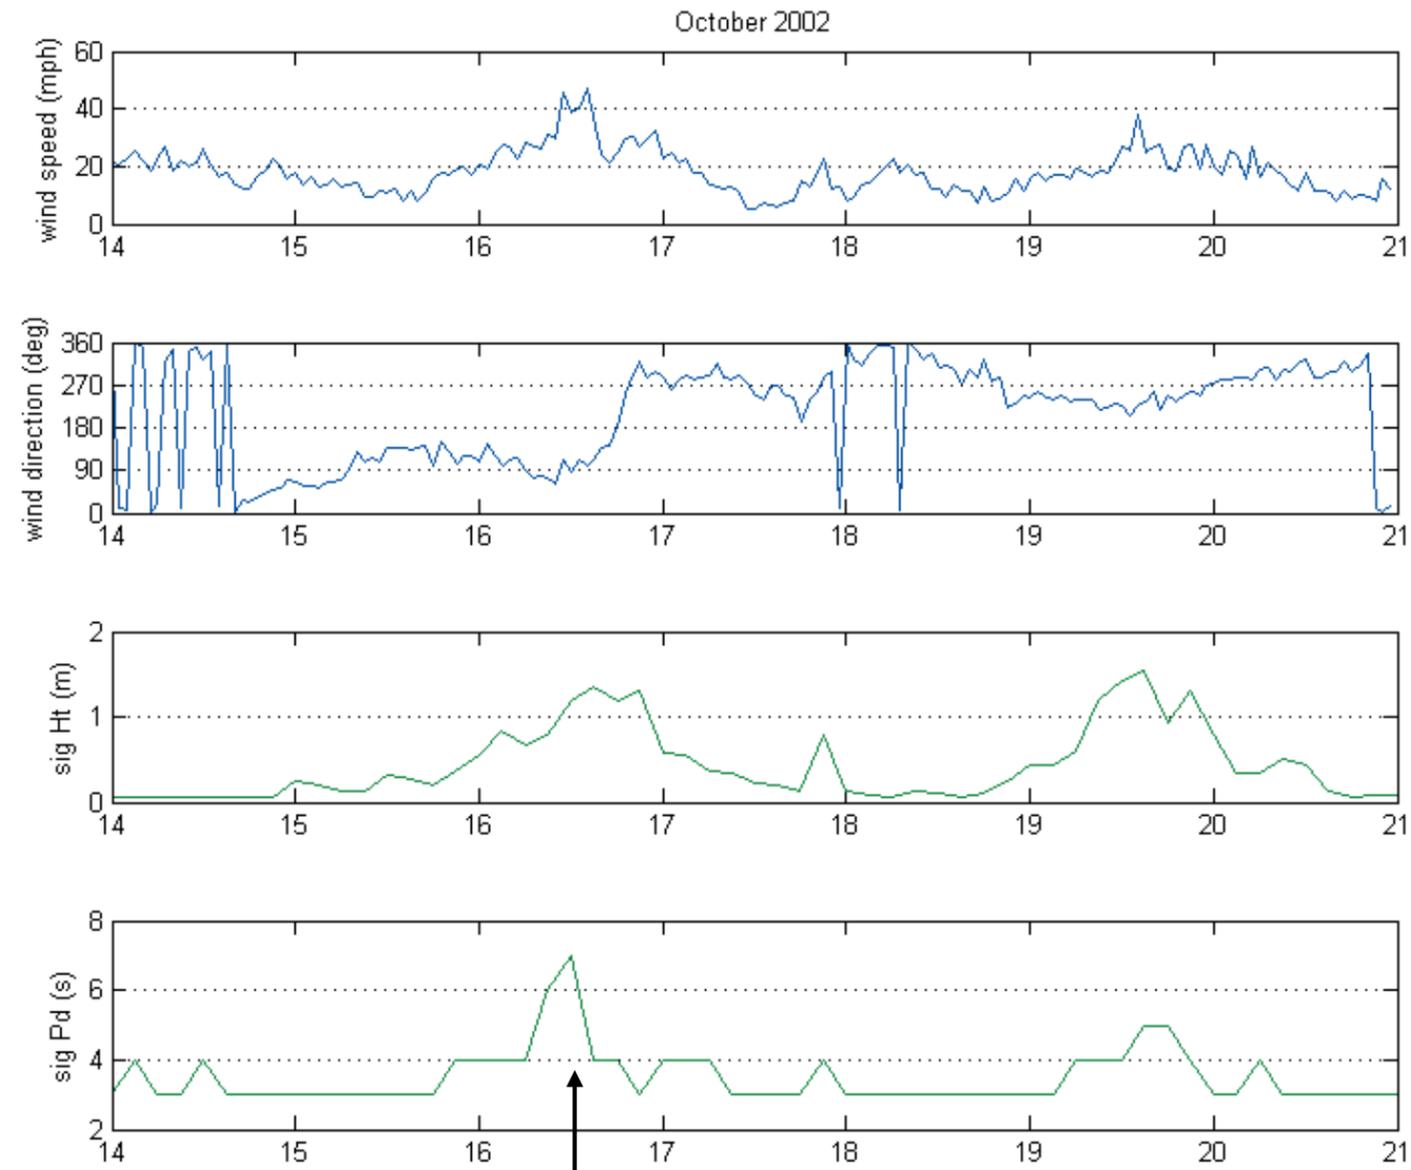
Figure 6 Wind and Wave Conditions – Branford Connecticut Station – October, 2002
 Arrow shows waves produced by a system similar to the event of December 16, 2005
 Meteorological Data from Central Long Island Sound Buoy – MYSOUND – Wave Height in Meters

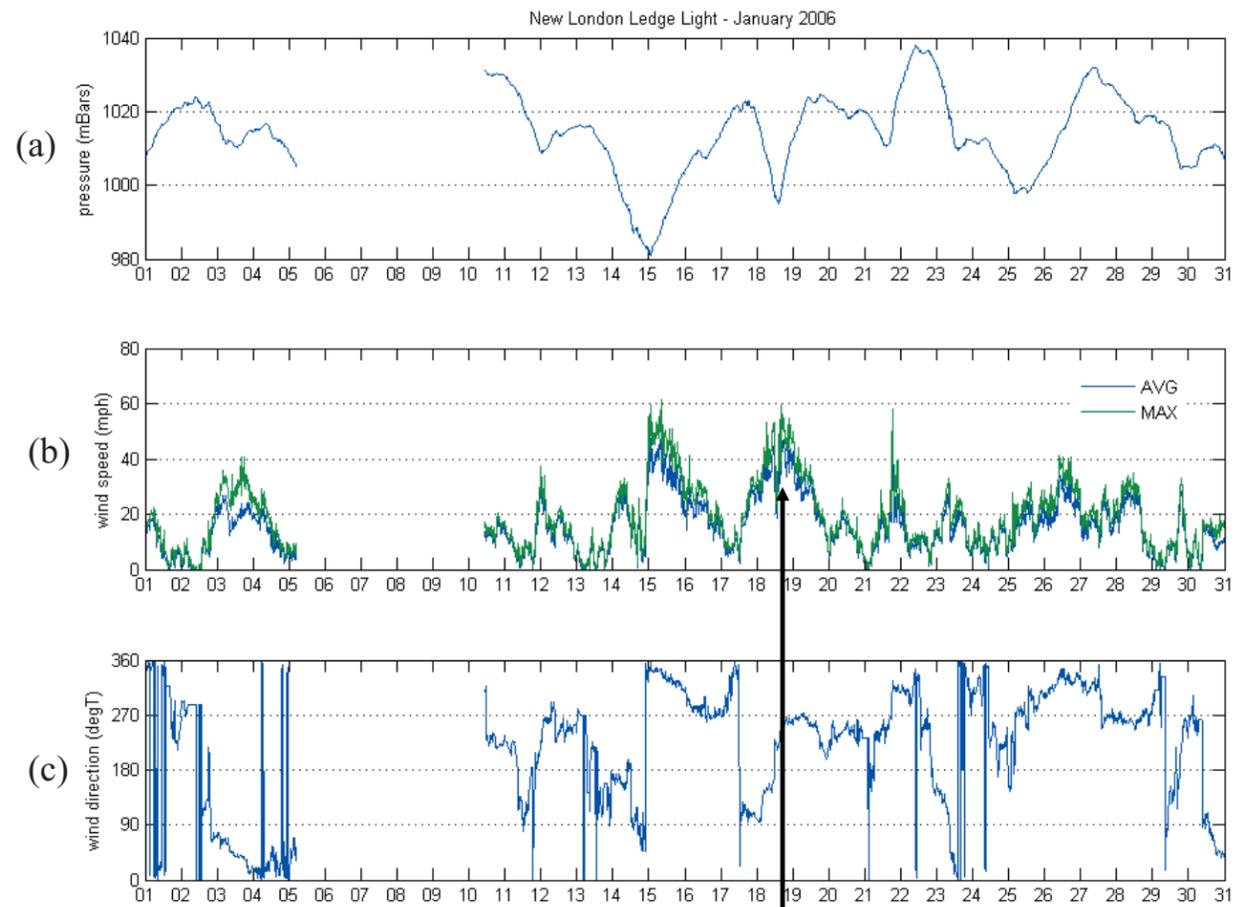
Figure 7 Meteorological Data – New London Ledge Station – January, 2006
 (a) Barometric Pressure (b) Wind Speed (c) Wind Direction
 Arrow Designates the Event of January 18, 2006

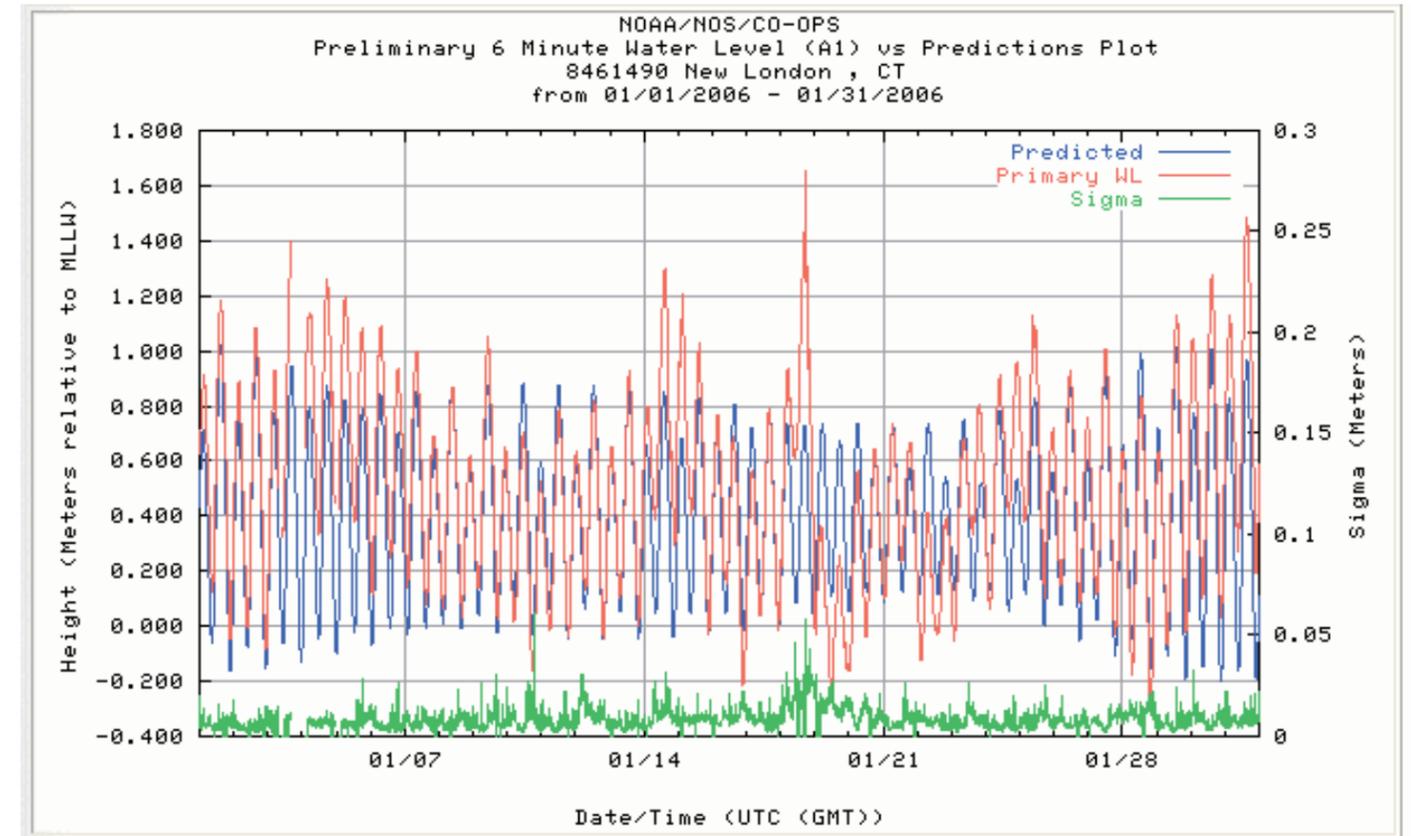
Figure 8 Tidal Elevations predicted and observed – New London Station – January, 2006
 Note: Height in meters

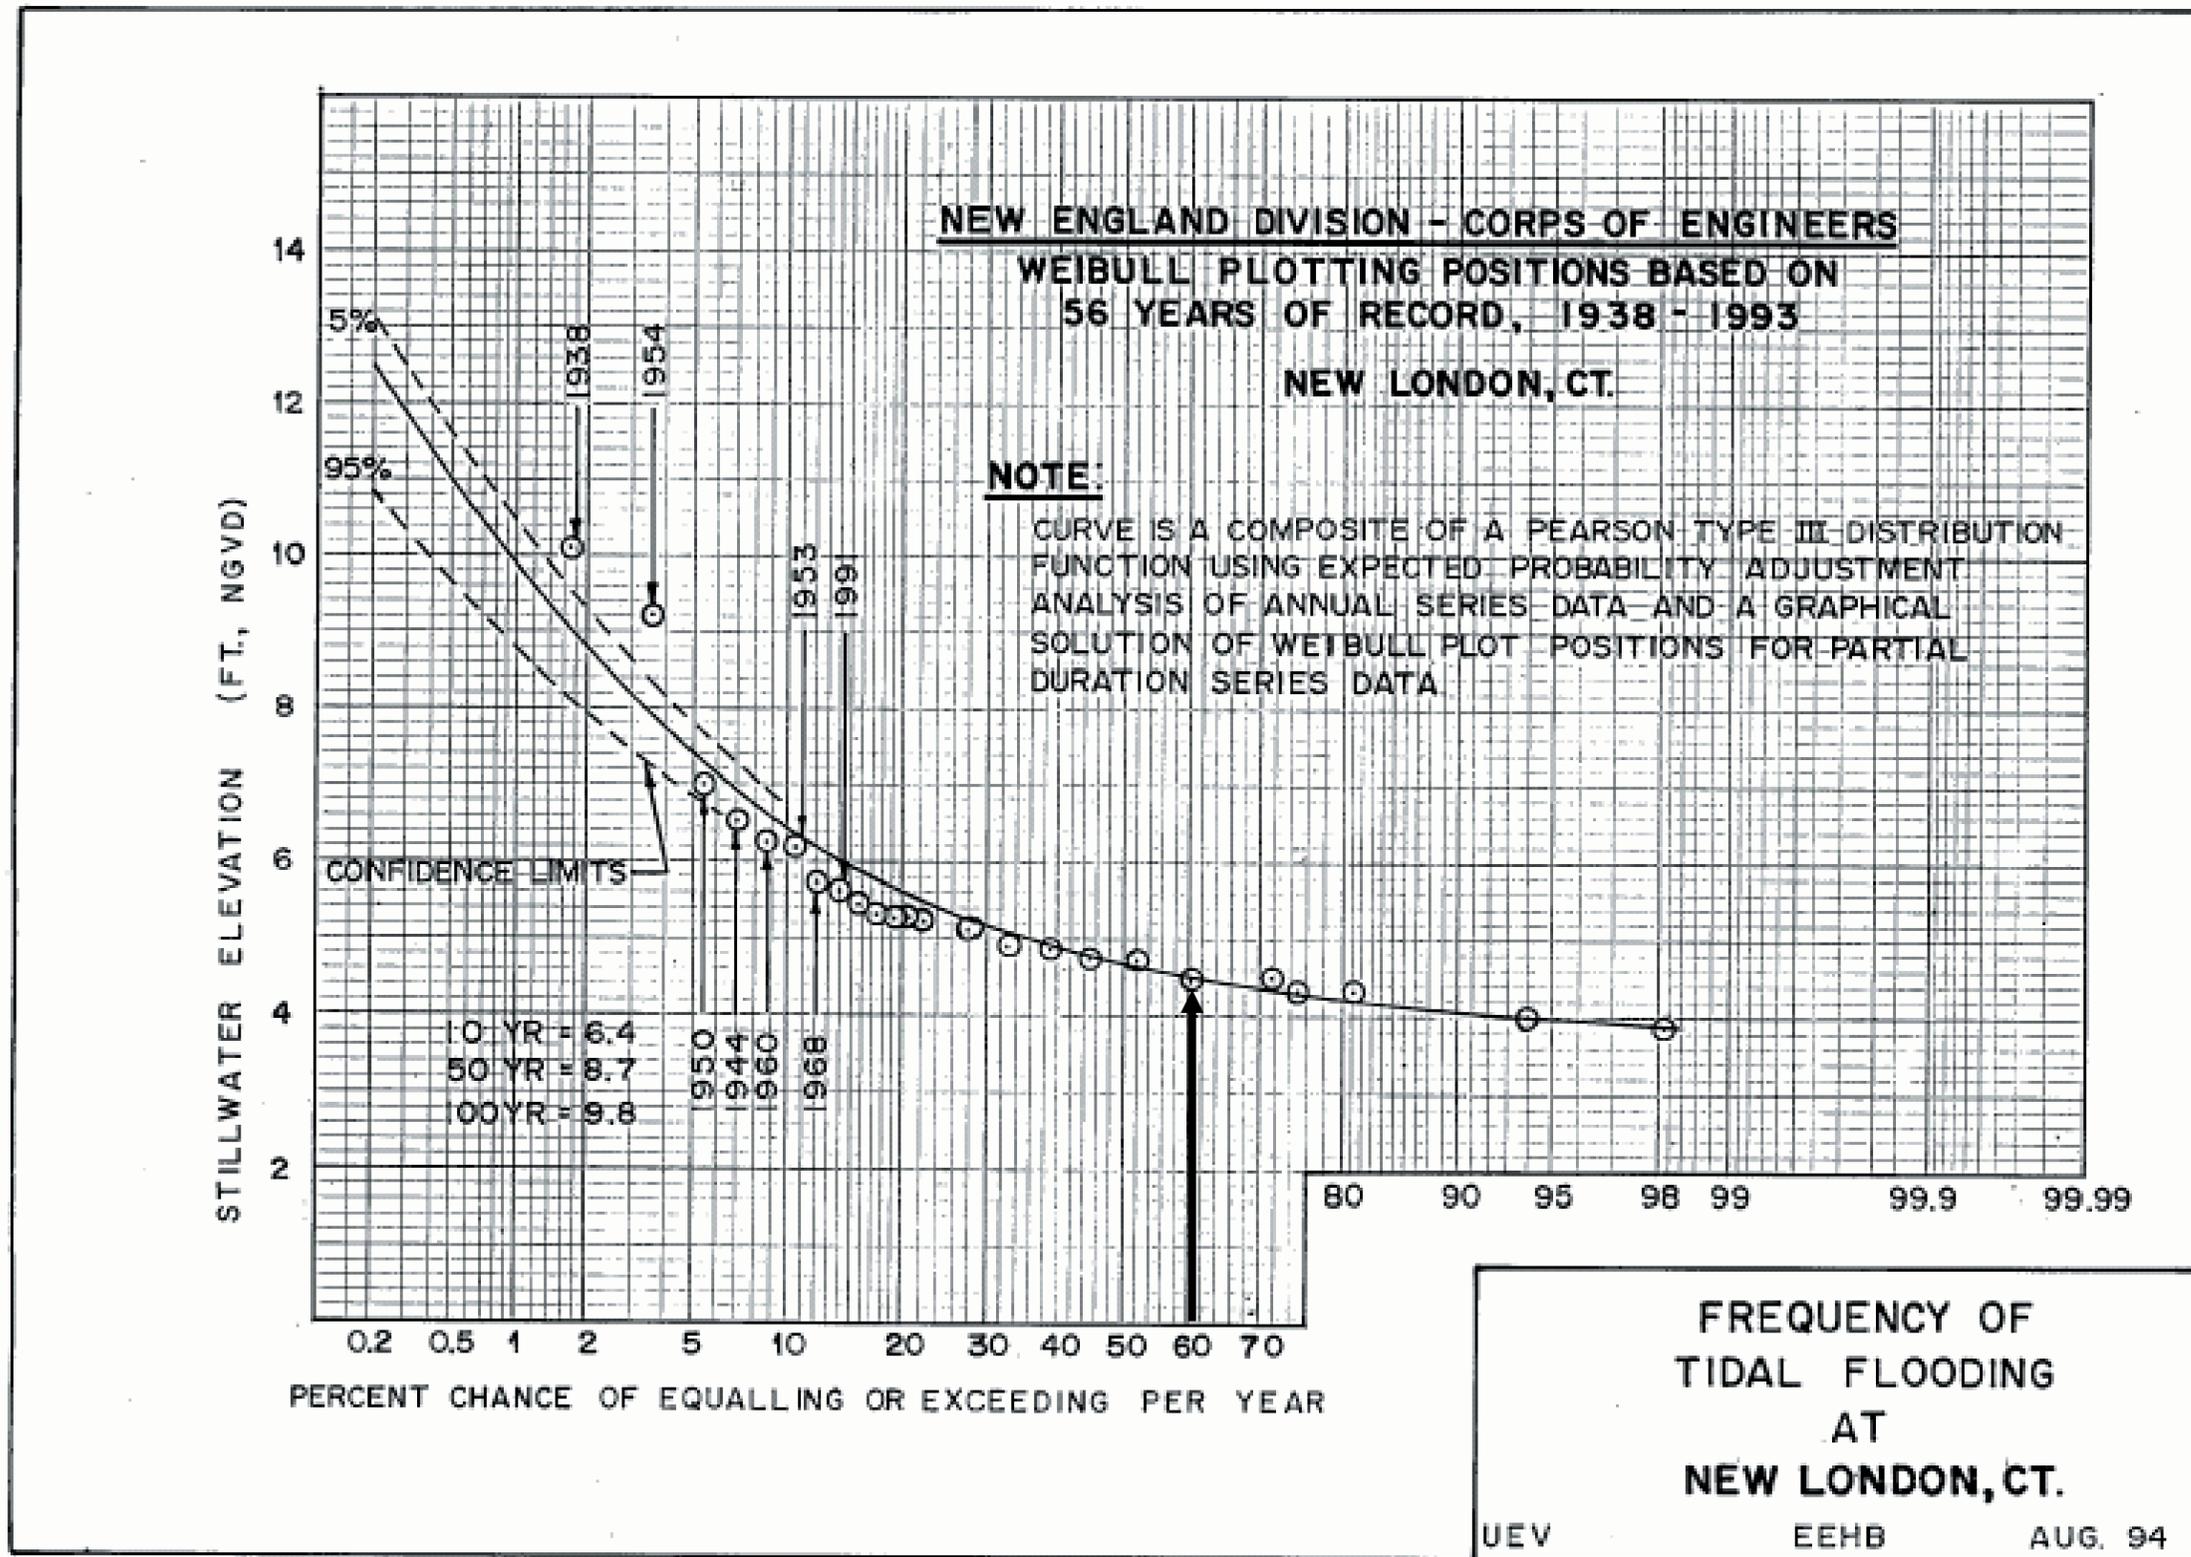
Figure 9 Expected Recurrence Frequency – Tidal Heights – New London, Ct.

U.S. Army Corps of Engineers – Concord, Ma. – File Data

Arrow indicates conditions associated with the event of January 18, 2006
