# East Lyme Public Trust Foundation, Inc.

February 1, 2015

Volume 3 Number 2

### Niantic Bay Boardwalk Reconstruction Progress

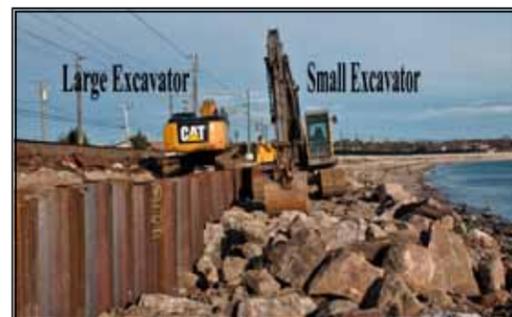
The photograph above depicts the process by which riprap is placed along the sheet pile bulkhead. The larger excavator on the left is driving piles. The smaller excavator on the right is placing riprap on the ocean side of the sheet pile bulkhead. It is adjusting and placing stone that is native to the area, or that is brought to the site or that is excavated at the site.

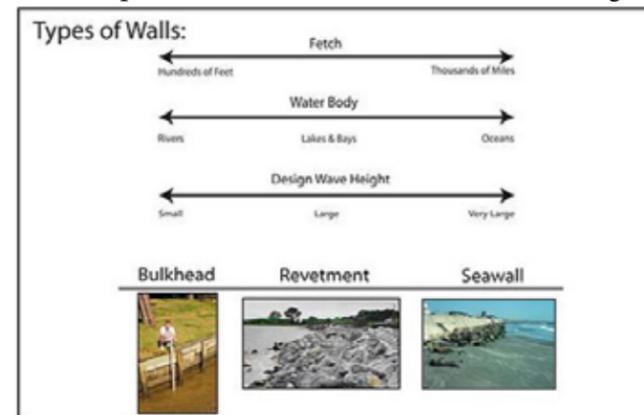
The photograph at the bottom of this page is of a revetment along a bay shoreline designed to protect a local road from erosion by waves during storms. An example of this design is pictured at the right and has a stone revetment extending from below the water surface up to a sheet pile bulkhead, which has a concrete cap on the piles that run parallel to the roadway shoulder. Storm surges can exceed the pavement elevation here. The concrete cap reinforces and stiffens the sheet piles that were driven into the shore line under the concrete cap before the cap was constructed. This is the same design

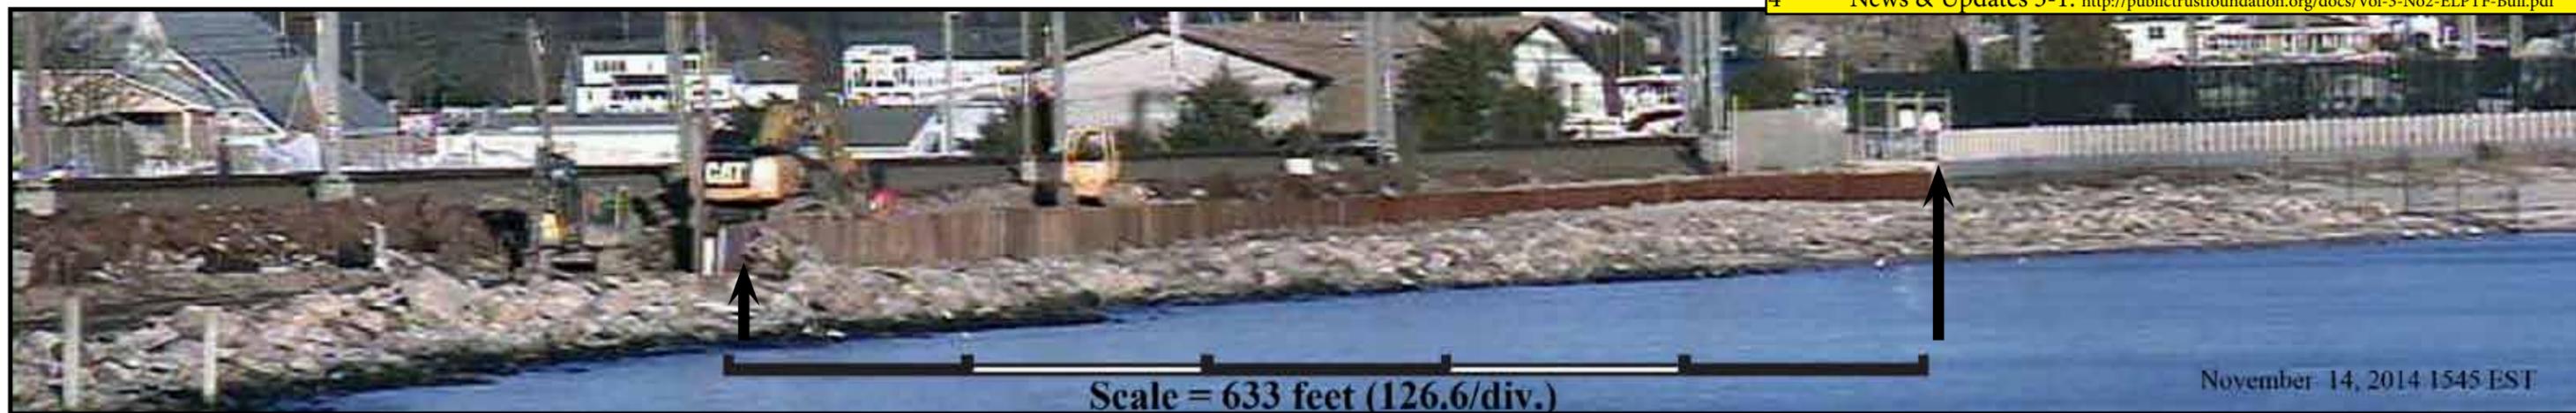
status of reconstruction of the Niantic Bay Boardwalk can be seen in “real time” by viewing it through the webcam hyperlink cited below<sup>2</sup>. The above photograph was taken through that webcam, which is approximately 3,000 feet away from the work site seen here.

The scale bar on the photograph measures the length of the first section of sheet pile bulkhead that will protect the “Boardwalk” from waves and storm tides. That bulkhead is armored by stone riprap (i.e. Riprap, also known as rip

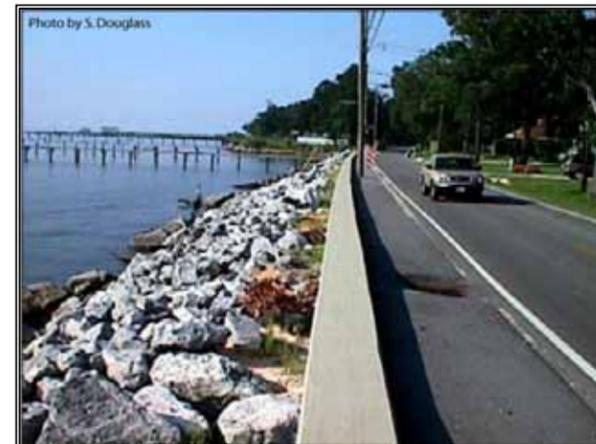
feature specified for the Niantic Bay Overlook, with the exception that in Niantic, the cap will carry a safety railing defined in News and Updates Vol. 3 No. 1 at the hyperlink cited below<sup>4</sup>. The diagram at the right is based on many years of experience and design applications and is published by the U.S. Federal Highway Administration. By

these guidelines, the design specifications being used on the Niantic Bay reconstruction project is intended to resist storm characteristics that have a frequency of once in one hundred years.

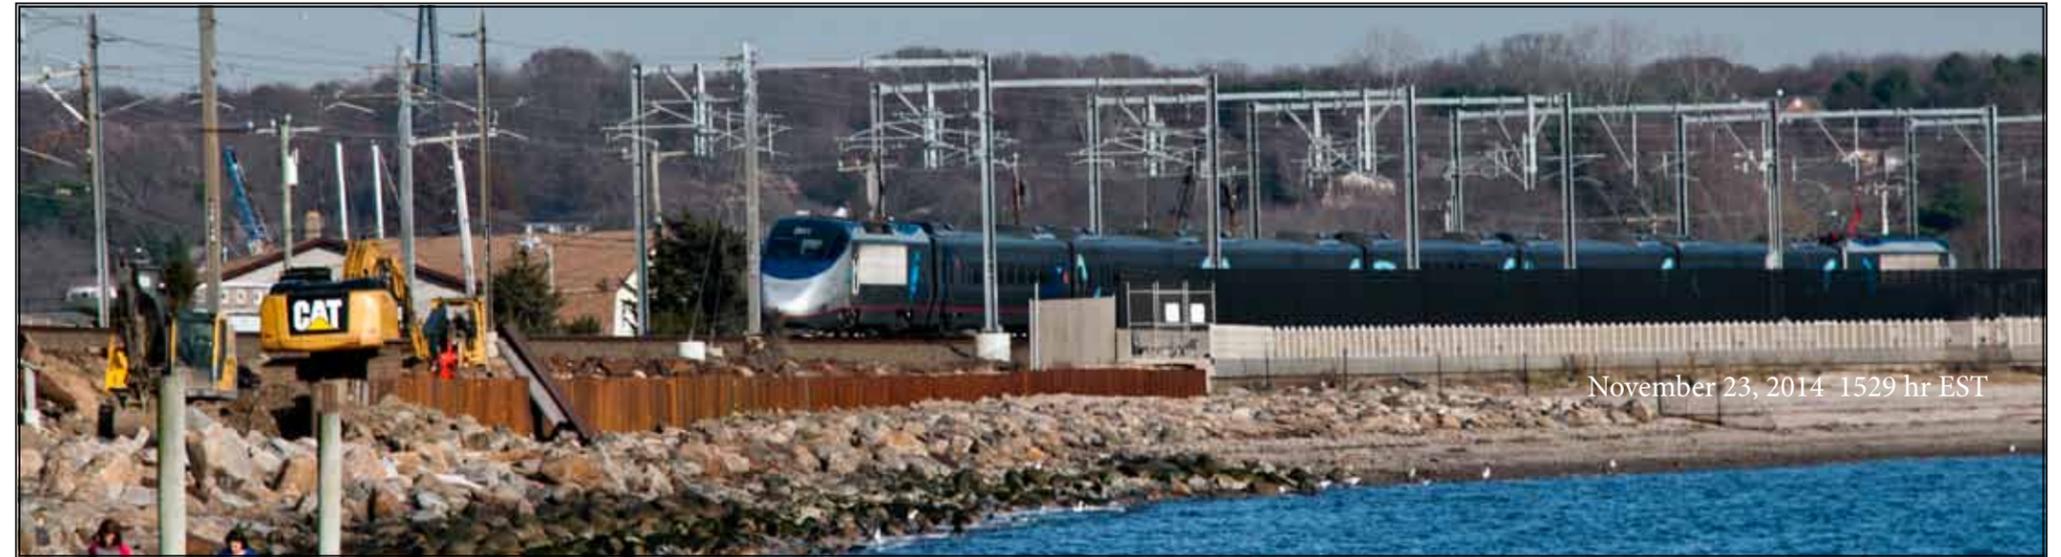
The photograph above, shows the revetment along the western half of the boardwalk where it starts at the end of the eastern half of the boardwalk that was reconstructed by Amtrak. The steel sheet pile bulwark of the western half of the boardwalk, which is 671 linear feet long in this photograph taken on November 11, 2014, was constructed in 41 work days beginning on September 25, 2014.

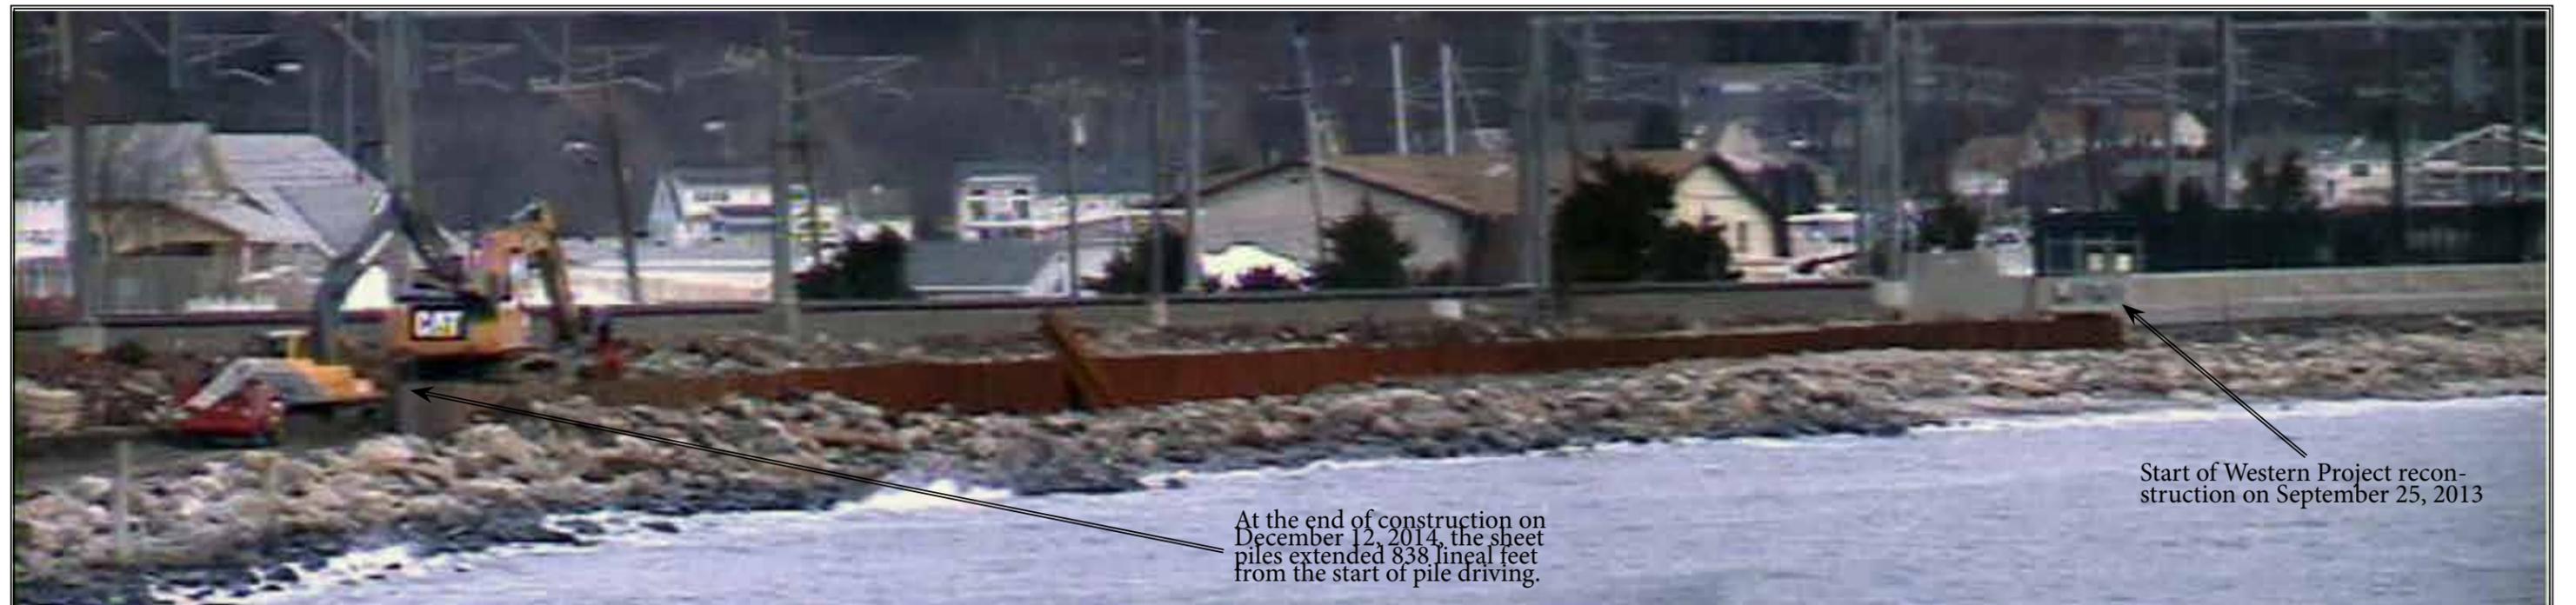
The photograph at the bottom of this page was taken on December 12, 2014, and is a panorama of three combined sequential images captured from the security video camera that sweeps 360° every twelve minutes from its vantage point near the Hole in the Wall on the shore line of Niantic Bay.

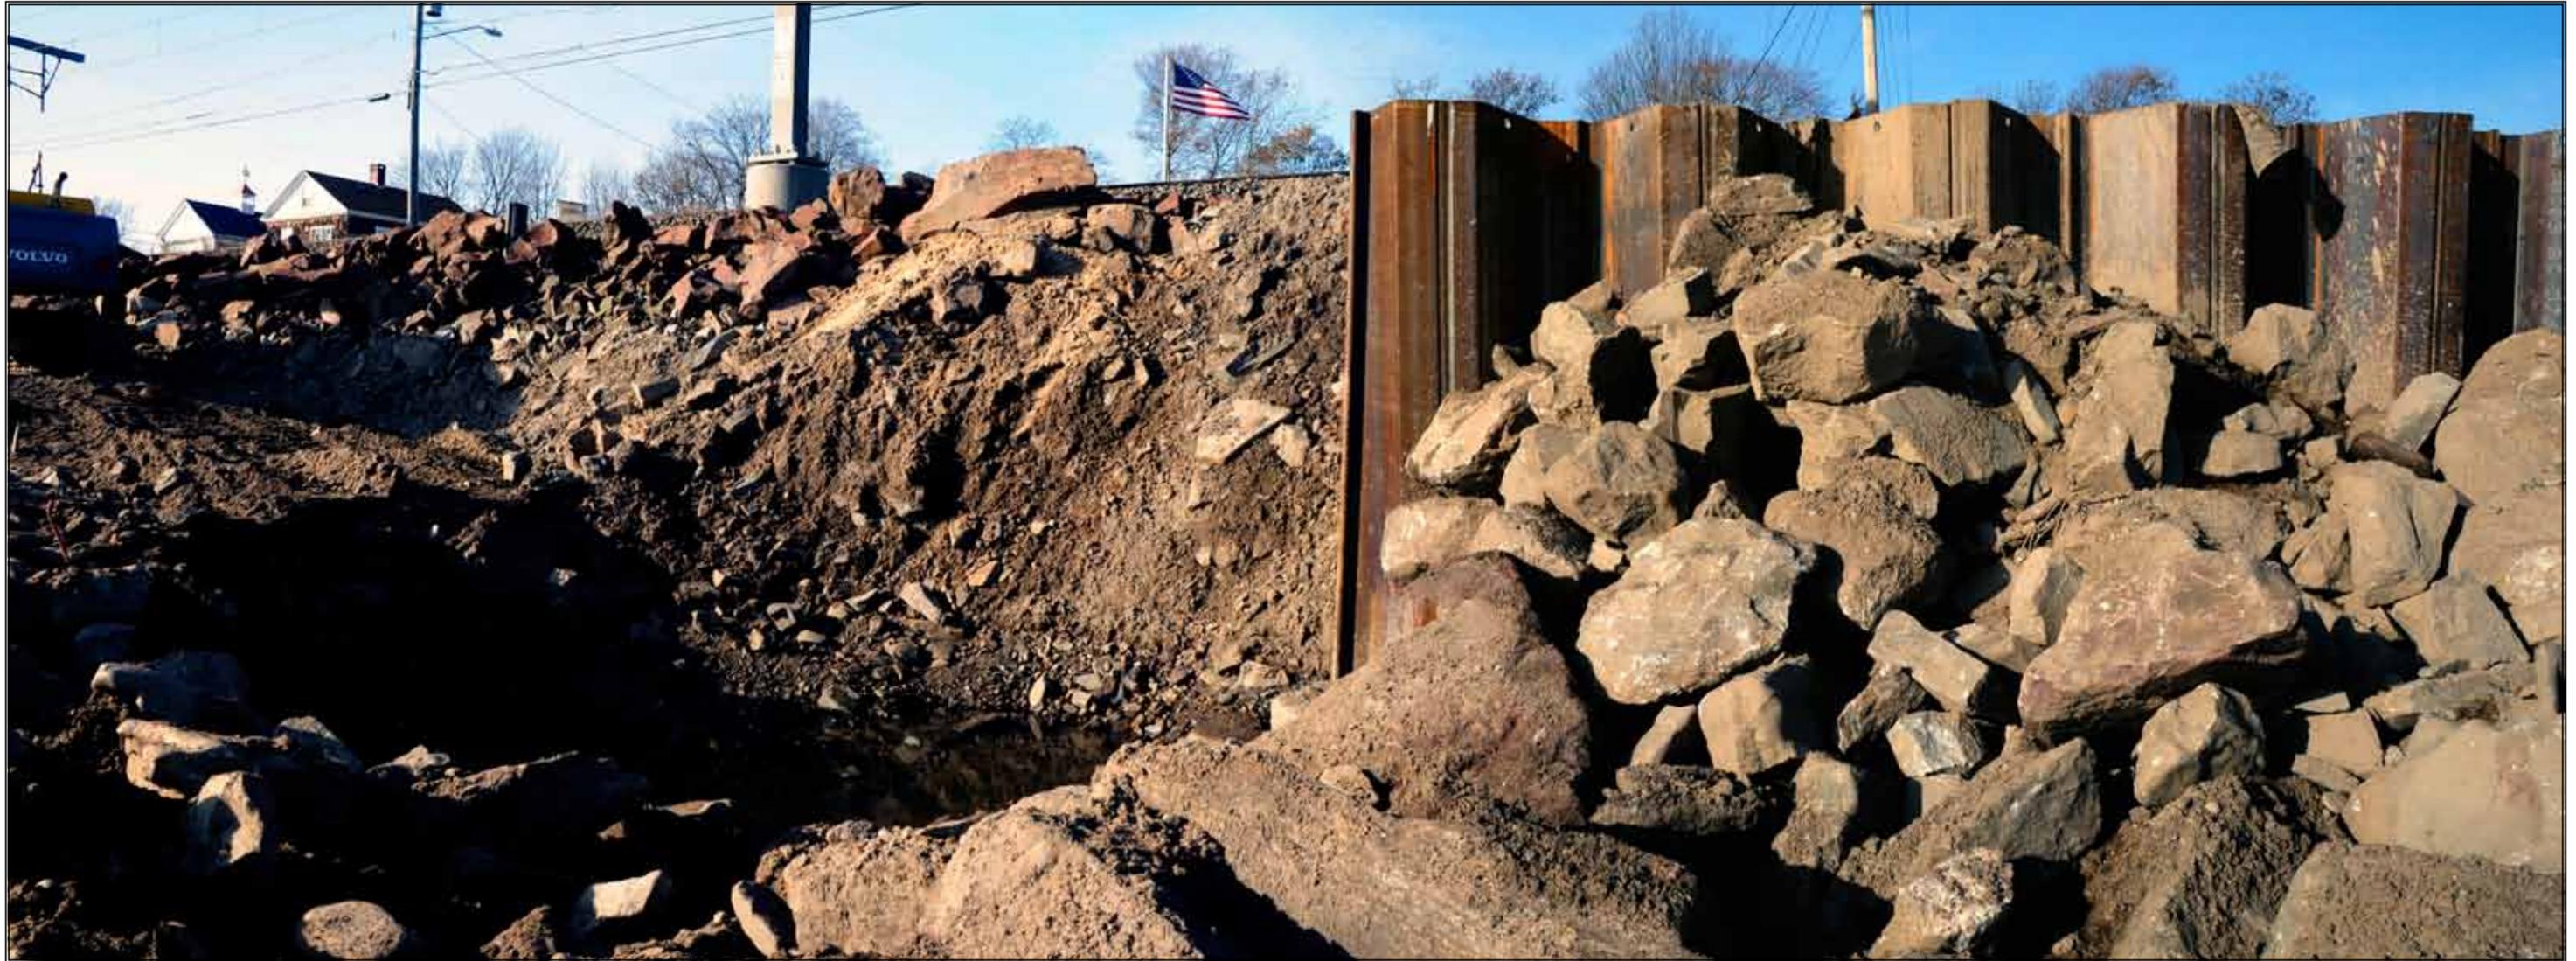
The photograph above was taken at the end of the 41<sup>st</sup> work day of construction (November 21, 2014). It shows the excavation needed to remove subsurface stone that had impeded driving the last pile of that day. Some of the stone removed from the hole in the center left of the photograph was deposited along the completed bulkhead on the right of the photograph. The location of this bulkhead section along Main Street (Route 156) lies across from Skippers Restaurant. The flag in front of that address is seen in the top center of this view.

viewing it at the hyperlink cited in Footnote 8.<sup>8</sup> A critical issue that faces this project is construction delays that may result from pile driving do to the possibility of encountering subsurface obstructions, such as stone, and more significantly, boulders that must be excavated and removed from obstructing the placement of the sheet piles.

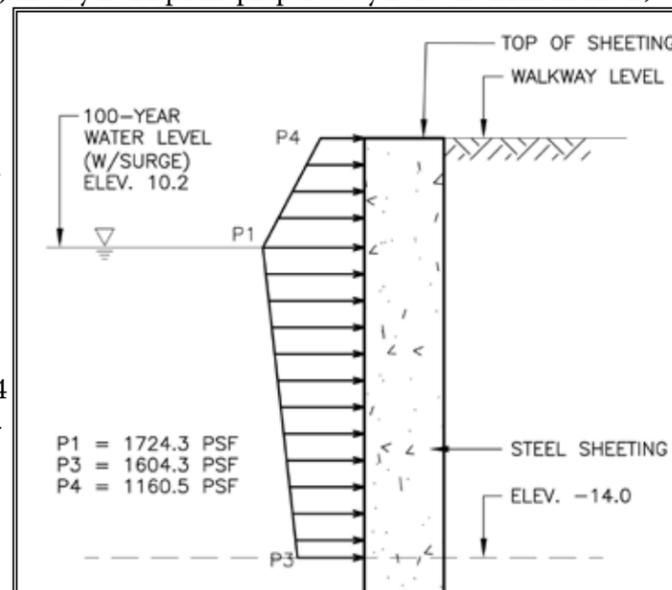
The diagram to the right was taken from the General Notes in the project drawings and illustrates the wave forces that are expected to impact the bulkhead of the project revetment. These forces were calculated by Applied Coastal Research & Engineering, Inc. of Mashpee, Massachusetts, and, in-

form the design and material specifications of the boardwalk, its foundation, and all aspects of its functional characteristics, as they are presented on Sheet S-0 (i.e. Page 29) of the January 2014 plans prepared by Parsons Brinckerhoff, Inc. design engineers in Boston, Massachusetts. These project plans are available through the hyperlink cited in Footnote 9.<sup>9</sup>

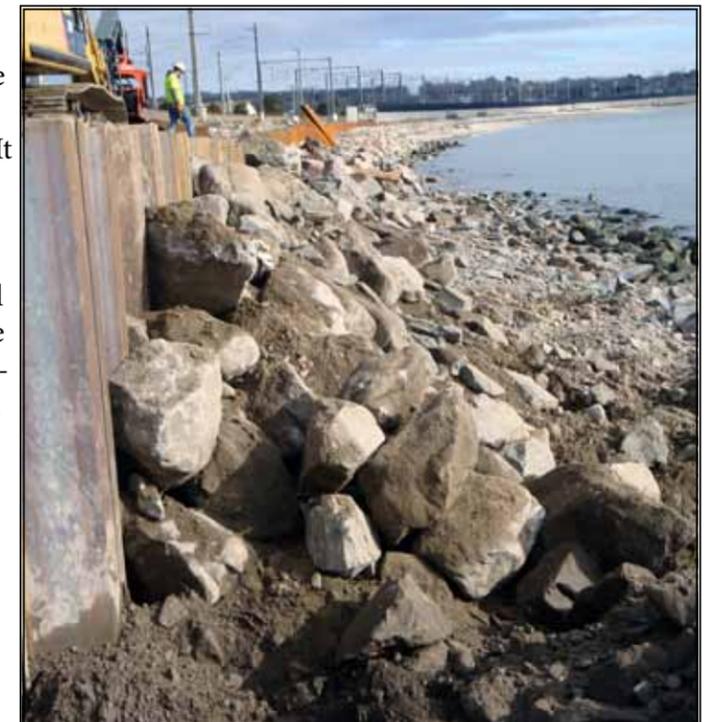
The photograph at the right was taken on December 12, 2014. It illustrates the result of the contractor’s work laying large stone against the steel sheet piles to hold the bulkhead vertical. Outward pressure against the piles, caused by backfilling and compacting the sand and gravel foundation of the walkway, would otherwise cause the sheet piles to deform and bow outwardly.
