East Lyme Public Trust Foundation, Inc.

Niantic Bay Boardwalk Reconstruction Progress

Eight months after Amtrak began replacement of the Niantic River Railroad Bridge, its two 12 hour, 6-7 day per week work shifts have resulted in remarkable progress. The Amtrak cross section drawing shown on the right depicts future track alignment and its relationship to the Overlook Walkway as it will appear in the spring of 2013. This cross section is located at Project Station 71 + 00, which is approximately opposite the east end of the Niantic River Transmission Garage on Route 156 (see Page 3). Its characteristics illustrated here are "typical" and represent the planned configuration all along the new sea wall extending to the new stone groin being built parallel to the Niantic River at the easterly end of the Park.

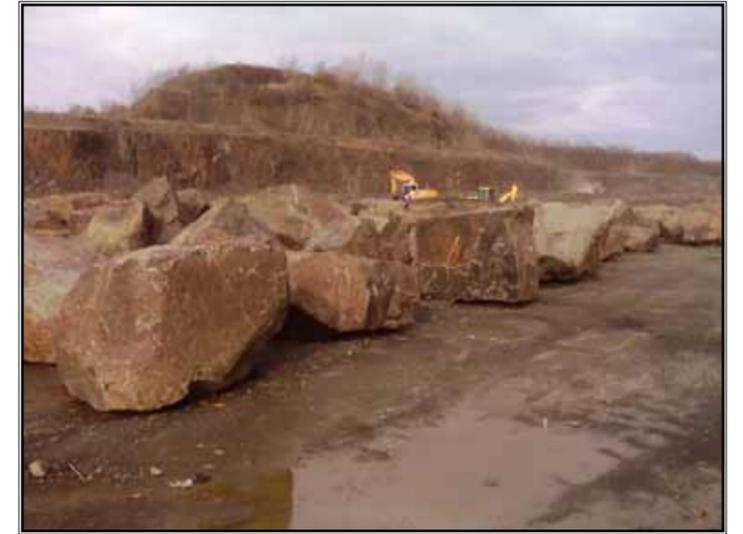
fractures, most typically hexagonal, but also four to eight sided. The fracture pattern forms when magma (i.e. molten rock in the earth's crust) intrudes as a sill or extrudes as a thick lava flow, and slowly cools. Much of the existing railroad embankment was build of such trap rock as this. It will be shipped by barge from the Tilcon Quarry in North Branford, Connecticut, then unloaded to a temporary dock at the groin and moved from there to be placed at the foot of the sea wall by trucks, one of which is pictured below, right..

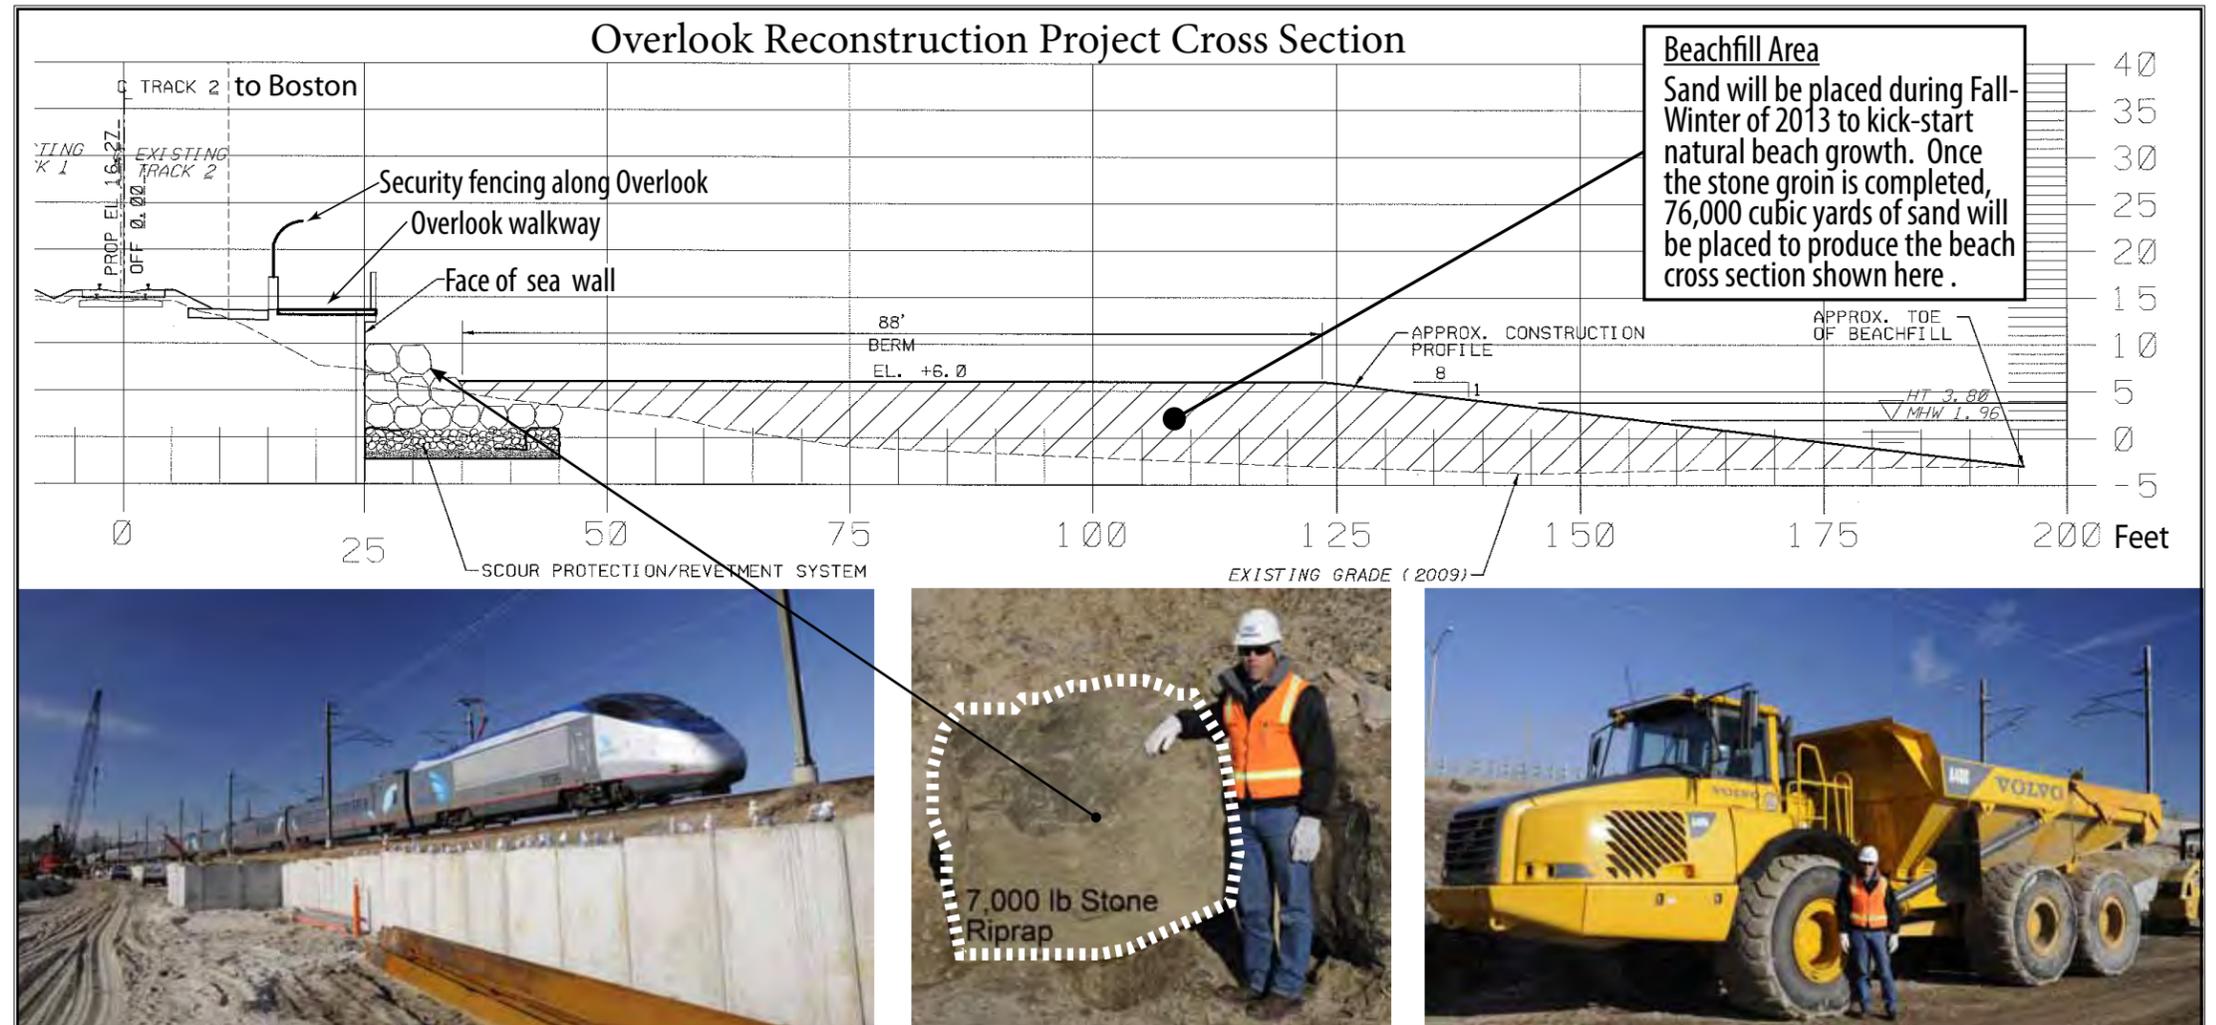
This ACELA train set is running toward Boston on existing Track 2, which is parallel to the sea wall, the location of which is diagramed in the above cross section. The reconstructed track bed and rails will have a relationship to the Overlook walkway similar to the one that exists today, separated from the Overlook by a kneewall and mesh security fence.

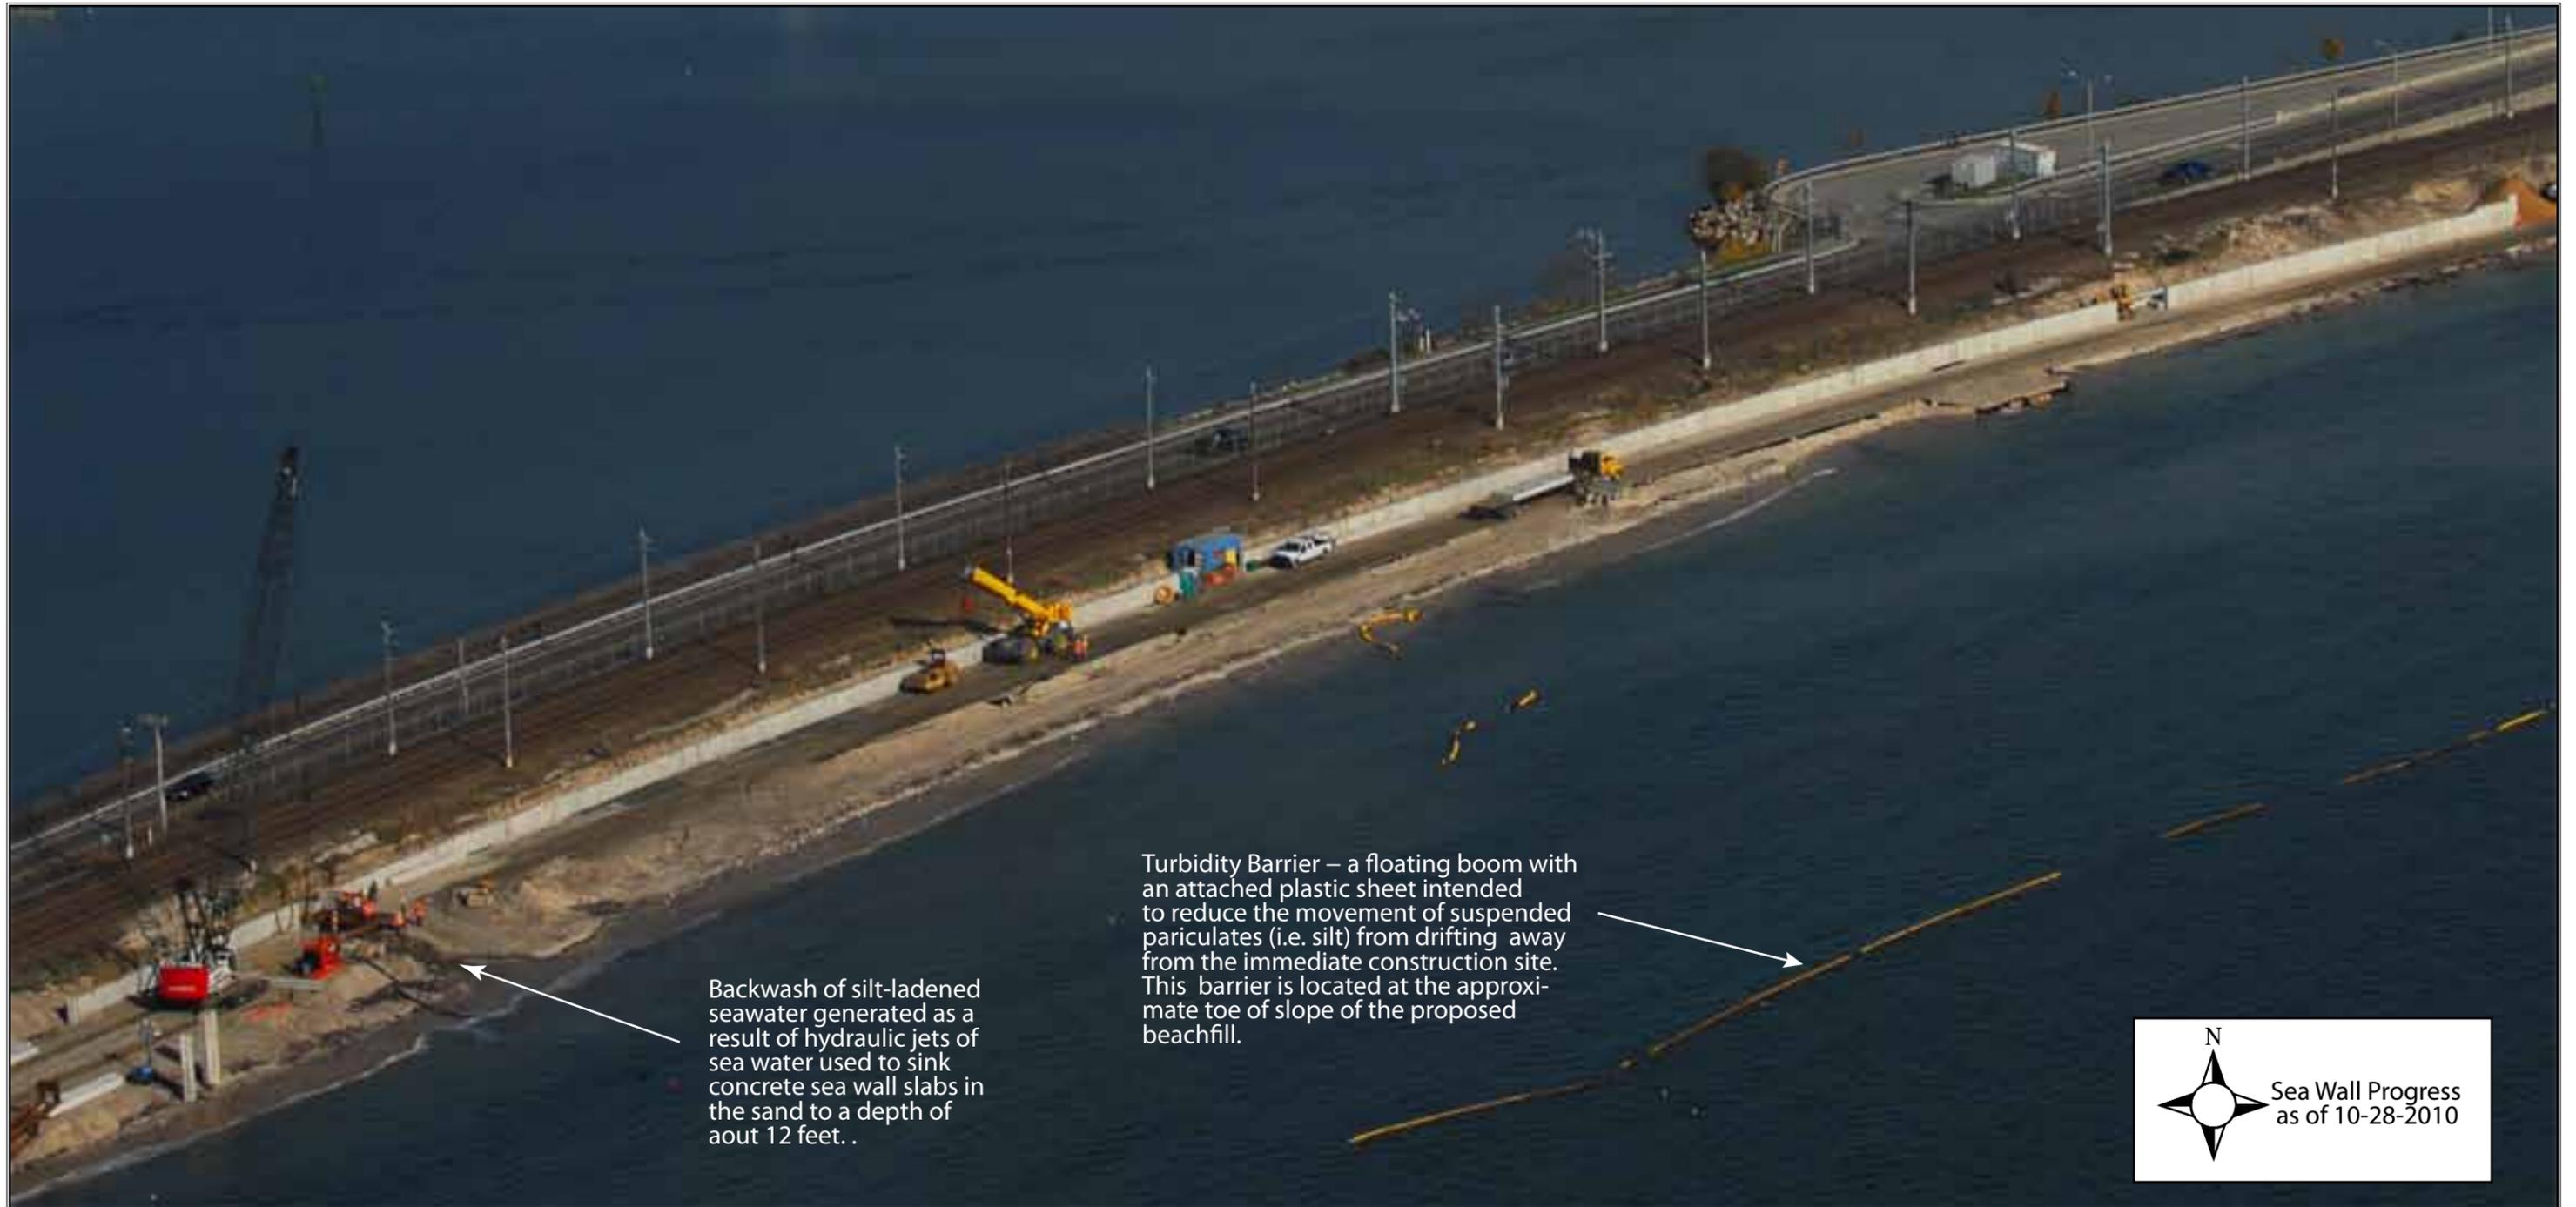
← Backwash of silt-laden seawater generated as a result of hydraulic jets of sea water used to sink concrete sea wall slabs in the sand to a depth of about 12 feet.

→ Turbidity Barrier – a floating boom with an attached plastic sheet intended to reduce the movement of suspended particulates (i.e. silt) from drifting away from the immediate construction site. This barrier is located at the approximate toe of slope of the proposed beachfill.

Taken on Thursday, October 28, 2010, at about 12 noon, this overview shows most of the sea wall construction site. The Turbidity Curtain that parallels the beach is a water quality protection device. It helps to contain turbid waters created as a consequence of construction, and in this project especially the silt and sand that is suspended in the backwash of sea water used to hydraulically jet in the sea wall panels. The objective of this turbidity barrier is to reduce movement of silt away from the construction site. The State specifies that such “turbidity curtains” be employed to accomplish the following:

Note that the position of the Turbidity Curtain marks the anticipated extent of the placed 76,000 cubic yards of beach sand fill. The grain size analysis of the existing beach sand and the analysis of the sand proposed for use to nourish and accelerate beach creation is provided. Those analyses are accompanied by the annotated cross section of the new beach profile. The APPROX. TOE OF BEACHFILL, is coincident with the Turbidity Curtain depicted in the aerial photograph above.

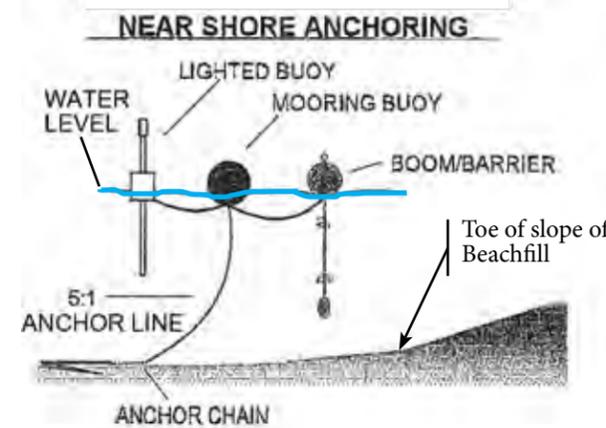
The cross sectional diagram to the right illustrated the main components of the Turbidity Curtain deployed here.

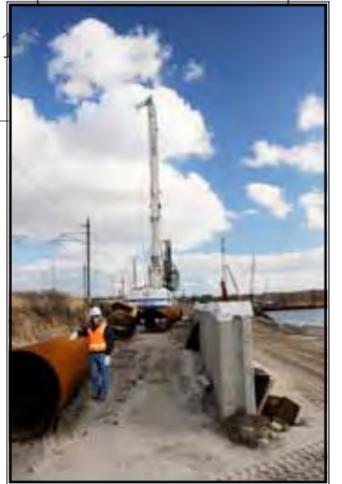
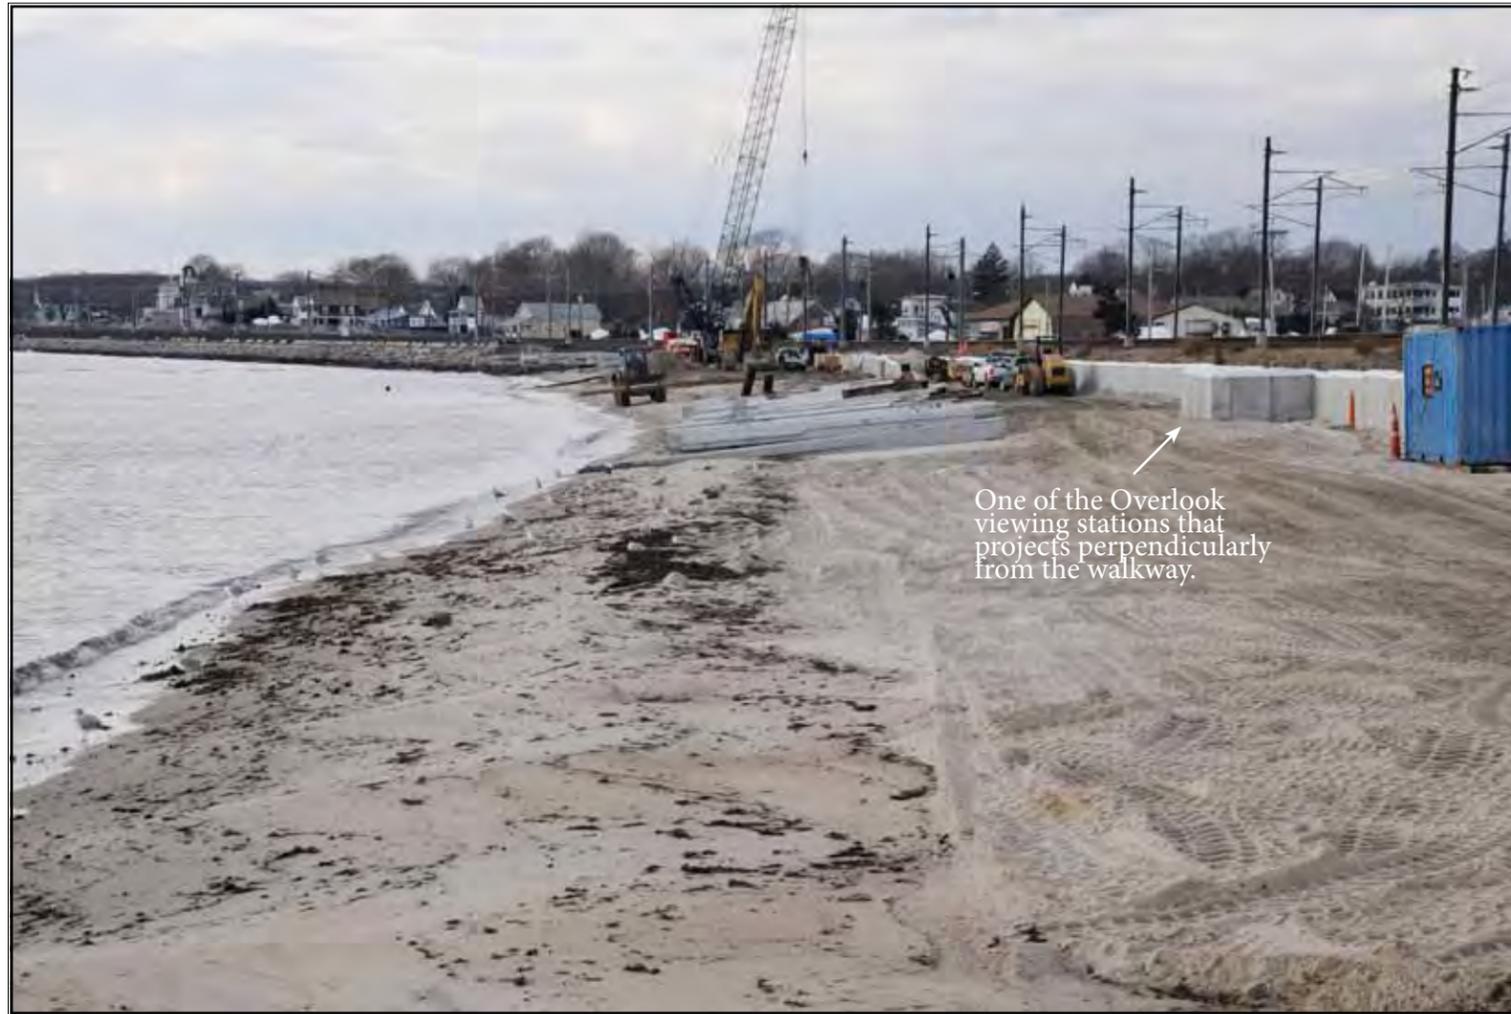
The **Soilmec**, pictured at the right in the background, is used to drill 52 inch diameter holes to remove obstructing bed rock or boulders that would otherwise prevent the safe placement of foundation piles or similar structures, close to the working railroad tracks. Special care is required so as not to excavate near railroad embankments that might cause the rail bed to shift or fail due to movement of its supporting foundation as a direct or indirect consequence

of unregulated excavation. Therefore, as the **Soilmec** holes are being drilled, the steel pipe, shown here lying next to the Amtrak Project Manager, is used to temporarily line the hole. Once the hole is drilled to the necessary twelve or more feet, sand is placed in the hole and then the pipe is withdrawn. The desired and preformed foundation structure, sheet pile or catenary pole is inserted in the sand-filled hole. This involved and relatively expensive

The **Face of Wall** is the Sea Wall. Constructed of concrete panels, each 20 inches thick, four feet wide, and 38 feet long sheet pile is sunk about 12 feet into the beach using hydraulic methods developed in Florida and imported to this project by the contractors. If and when bedrock or boulders are encountered, the **Soilmec excavator** (see below) is employed to remove that obstruction. It drills

a 52 inch diameter hole, supporting the sides of the hole with a steel pipe that prevents collapse. Once drilled to the desired depth, the pipe-lined hole is filled with sand and the pipe is then removed. Sheet pile, or other preformed structure, is sunk in the sand by hydraulic jetting, as described previously.

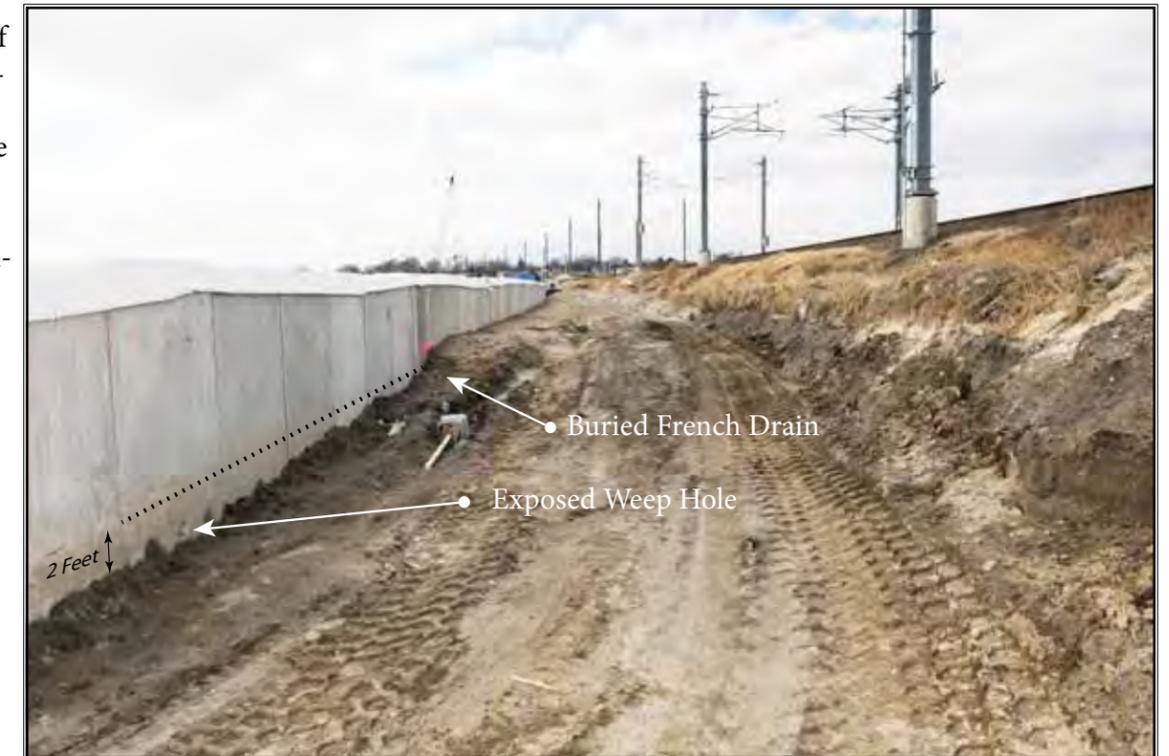
The view below looks westerly toward Hole In The Wall and illustrates the construction process used to install the two foot diameter French Drain buried along the north side of the sea wall. The drain consists of coarse gravel, shown in the photograph below, which is used to fill a porous geotextile wrapped around the gravel which lies against the sea wall, buried at the elevation of the weep holes. Construction of the French Drain is progressing in the direction of the camera.

Additional fill will be added to that shown in this view and the Overlook Walkway surface will finally be constructed at the elevation of the top of the sea wall. Fencing will finish the construction of the walkway elements of the Overlook including the original fencing that will be replaced on the ocean side of the Overlook and a new mesh security fence that will separate the walkway from the railroad embankment proper.

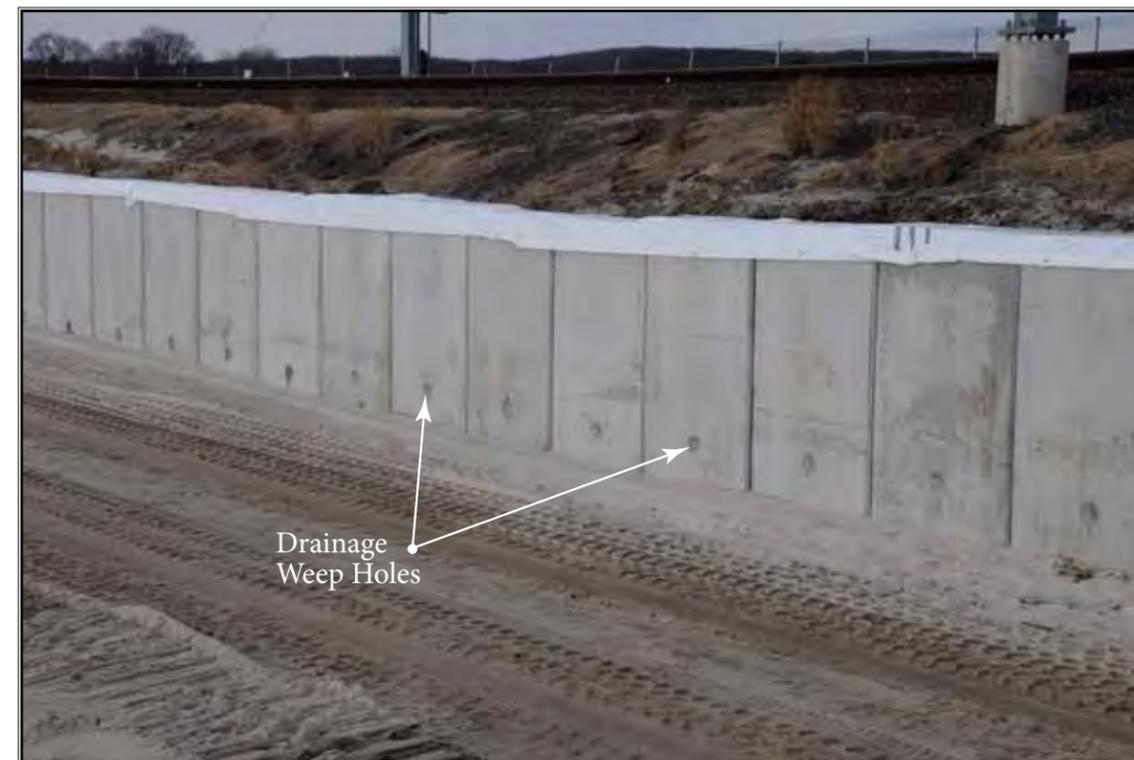
Photographs on this page were taken on January 5, 2011, to depict progress made along the westerly portion of the Amtrak project. The placement of the segmental sea wall, comprised of 4x1.7x38 foot concrete sheet piles, nears completion.

These photographs depict one of the detail involved in this stage of constructing the sea wall and foundation structures that will support the Overlook Walkway and its access to the new beach areas. Construction of a French Drain is needed to help conduct ground water away from the upland side of the sea wall, relieving hydraulic pressure on the wall by directing drainage onto the beach and away from the Overlook walkway and the railroad embankment.

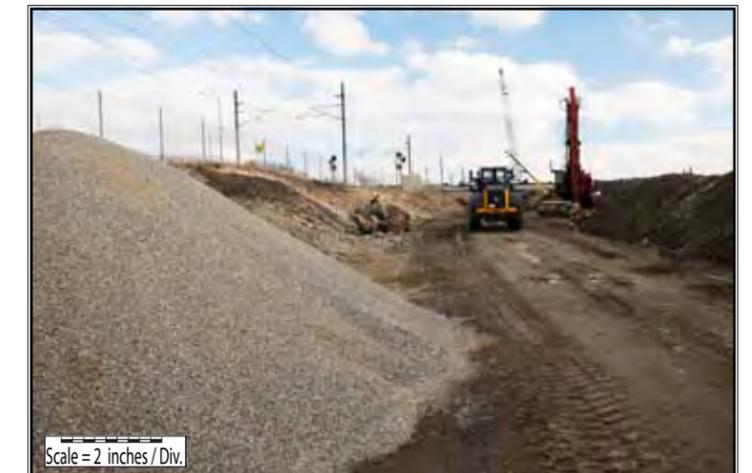
Coarse gravel shown here (#8 - washed 1/2 inch) fills the French Drain, defined above. This view is looking east toward the Niantic River.
